Access Compliance Report Public Rights-of-Way (Curb Ramps)

Intersection ID: 13865 Main Street: CENTRAL AV Cross Street: TIMBER HOLLOW DR Location: NE **Severity Score:** 22.5 ADA ID: 25C35BA9558F Ramp Type: Combination1 Initial Pass/Fail: Fail **Overall Compliance: No**

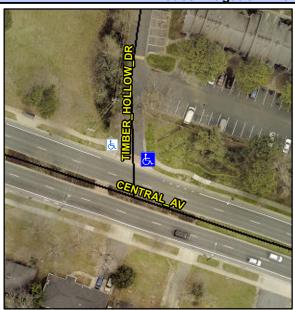
StopSign Street 1 Name TIMBER HOLLOW DR Stop Condition-Street 1 N/A Street 2 Name Stop Condition-Street 2 N/A Possible Solutions: Compliance Description N/A Remove & Replace Entire Ramp. Yes No Yes N/A No Surveyor Notes: N/A RT RP < 5%, NO LT SW N/A N/A N/A N/A PROW/ADA: N/A Not Found, R304.5.1, R304.5.3, N/A R304.3.2 N/A N/A N/A N/A N/A
