Access Compliance Report Public Rights-of-Way (Curb Ramps)

Intersection ID: 9841	Main Street: N_GRAHAM_ST	Cross Street: WOODWARD_AV	Location: SW
ADA ID: 25C7983190D7	Ramp Type: ParaDiag	Initial Pass/Fail: Fail	Overall Compliance: No Severity Score: 8.75

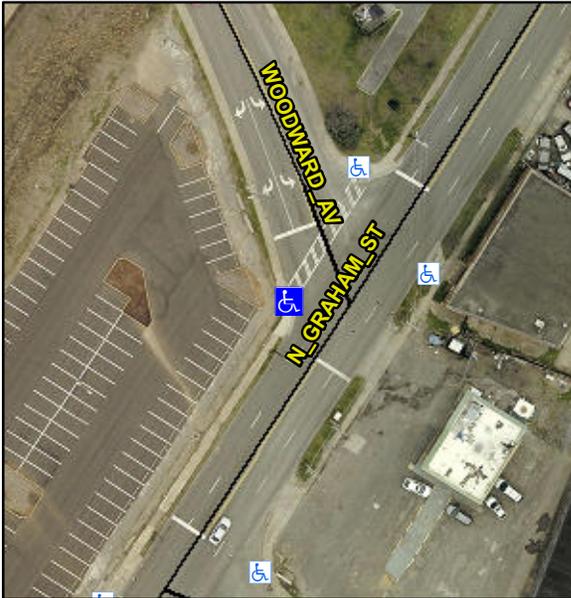
LT RP < 5%

Compliance	Description	Data	Compliance	Description	Data
N/A	Ramp Length LT (in)	61.5	N/A	Ramp Length RT (in)	92.5
No	Ramp Width LT (in)	47.5	No	Ramp Width RT (in)	47.5
Yes	Ramp Slope LT (%)	3.0	Yes	Ramp Slope RT (%)	5.9
Yes	Ramp XSlope LT (%)	0.7	Yes	Ramp XSlope RT (%)	1.5
N/A	Landing Length (in)	N/A	N/A	DWS Provided?	N/A
N/A	Landing Width (in)	N/A	N/A	DWS Contrast?	N/A
N/A	Landing Slope (%)	N/A	N/A	DWS Length (in)	N/A
N/A	Landing X Slope (%)	N/A	N/A	DWS Full Width?	N/A
N/A	Landing Curb? (Y/N)	N/A	N/A	DWS Offset (in)	N/A
N/A	Shared Landing?	N/A			
N/A	Gutter Ponding?	N/A	N/A	Gutter Slope (%)	N/A
N/A	Gutter Lip Ht (in)	N/A	N/A	Gutter X Slope (%)	N/A
N/A	Painted X Walk1?	No	N/A	Painted X Walk2?	Yes
	X Walk 1 Direction	To SE		X Walk 2 Direction	To NE
N/A	X Walk 1 Width (in)	N/A	N/A	X Walk 2 Width (in)	80.5
	X Walk 1 Slope (%)	1.5		X Walk 2 Slope (%)	2.9
	X Walk 1 X Slope (%)	2.3		X Walk 2 X Slope (%)	2.4
N/A	Ramp inside XWalk1?	N/A	N/A	Ramp inside XWalk2?	Yes

Road Slope (%)	1.5	N/A	Clear Space?	N/A
	Road X Slope (%)	0.7	N/A	Clear Space to XWalk (in)	N/A
N/A	Any Obstructions?	N/A	N/A	Storm Grate/Utility Hazard?	N/A
	Obstruction Type			Storm Grate/Utility Type	
		N/A			N/A
			Yes	Surface Condition? (G/P)	Good
			N/A	Curb Slope (%)	14.8

Possible Solutions:

Remove & Replace Curb Ramp With Two New Directional Ramps or Equivalent.
