Access Compliance Report

Public Rights-of-Way

(Curb Ramps)

Intersection ID: N/A	Main Street: E_STONEWALL_ST	Cross Street: S_COLLEGE_ST	Location: E
ADA ID: 25D3C80E01BF	Ramp Type: Perp	Initial Pass/Fail: Pass	Overall Compliance: No
Severity Score: 5.25			
Codes/Mitigation Info/Possible Solution		Field Measurements/Component Compliance

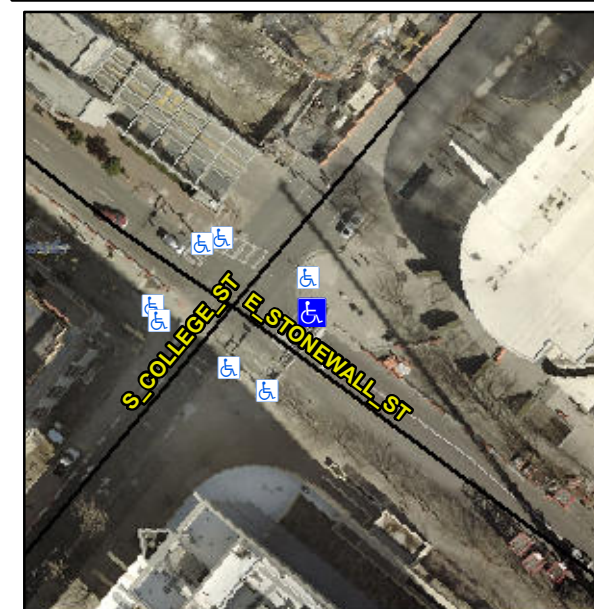
**Not Found, R304.5.3, R304.2.3,
R305.2**

Compliance	Description	Data	Compliance	Description	Data
N/A	Ramp Length (in)	74.0	Yes	Ramp Slope (%)	8.0
Yes	Ramp Width (in)	50.0	No	Ramp XSlope (%)	2.4
N/A	Flare Type LT	Sloped	N/A	Flare Type RT	N/A
N/A	Flare Slope LT (%)	14.1	Yes	Flare Slope RT (%)	4.0
N/A	Flare Traversable LT?	Yes	N/A	Flare Traversable RT?	Yes
Yes	Landing Length (in)	60.0	Yes	DWS Provided?	Yes
Yes	Landing Width (in)	48.0	Yes	DWS Contrast?	Yes
Yes	Landing Slope (%)	0.5	Yes	DWS Length (in)	24.5
No	Landing X Slope (%)	2.6	Yes	DWS Full Width?	Yes
N/A	Landing Curb? (Y/N)	No	No	DWS Offset (in)	5.0
N/A	Shared Landing?	No			
Yes	Gutter Ponding?	No	Yes	Gutter Slope (%)	3.4
Yes	Gutter Lip Ht (in)	0.0	No	Gutter X Slope (%)	2.4
N/A	Painted X Walk1?	Yes	N/A	Painted X Walk2?	N/A
	X Walk 1 Direction	To SW		X Walk 2 Direction	N/A
N/A	X Walk 1 Width (in)	111.0	N/A	X Walk 2 Width (in)	N/A
	X Walk 1 Slope (%)	2.2		X Walk 2 Slope (%)	N/A
	X Walk 1 X Slope (%)	1.8		X Walk 2 X Slope (%)	N/A

Yes	Ramp inside XWalk1?	Yes	N/A	Ramp inside XWalk2?	N/A
	Road Slope (%)	N/A	N/A	Clear Space?	Yes
	Road X Slope (%)	N/A	N/A	Clear Space to XWalk (in)	N/A
Yes	Any Obstructions?	No	Yes	Storm Grate/Utility Hazard?	No
	Obstruction Type			Storm Grate/Utility Type	
		N/A			N/A
			Yes	Surface Condition? (G/P)	Good

**Remove & Replace Entire Ramp.
Remove & Replace Gutter.**
