Access Compliance Report

Public Rights-of-Way

(Curb Ramps)

Intersection ID: 24984	Main Street: KENLAUREN_TR	Cross Street: PARK_CROSSING_DR	Location: NE
ADA ID: 25F048415F7B	Ramp Type: PerpDiag	Initial Pass/Fail: Fail	Overall Compliance: No
		Severity Score: 25

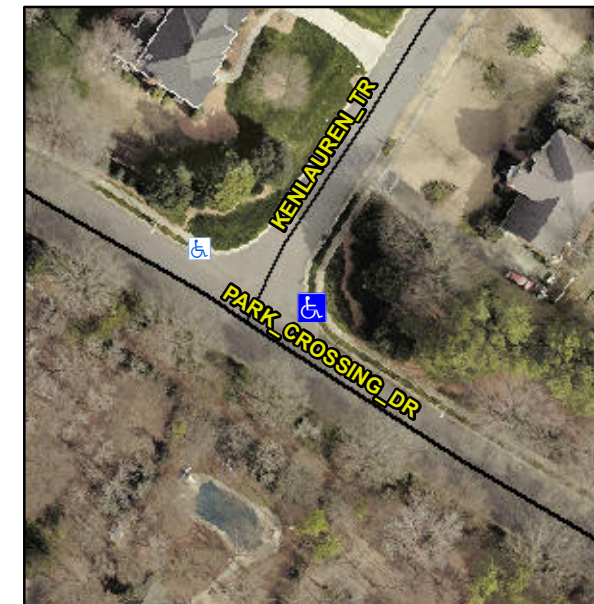
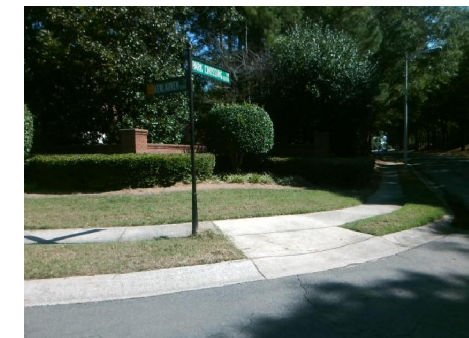
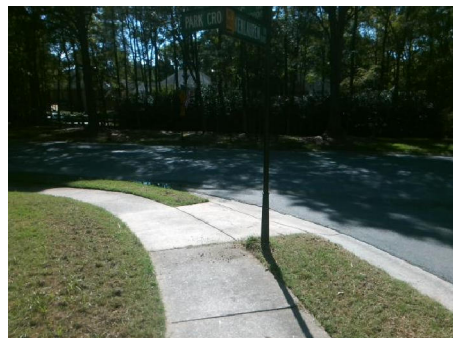
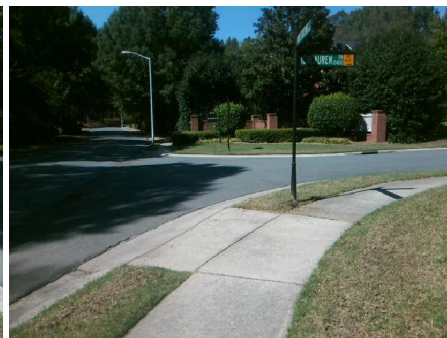
Not Found, R304.2.2, R304.5.3

Compliance	Description	Data	Compliance	Description	Data
N/A	Ramp Length (in)	40.0	No	Ramp Slope (%)	11.4
Yes	Ramp Width (in)	48.0	No	Ramp XSlope (%)	6.2
N/A	Flare Type LT	N/A	N/A	Flare Type RT	N/A
N/A	Flare Slope LT (%)	N/A	N/A	Flare Slope RT (%)	N/A
N/A	Flare Traversable LT?	N/A	N/A	Flare Traversable RT?	N/A
N/A	Landing Length (in)	N/A	N/A	DWS Provided?	N/A
N/A	Landing Width (in)	N/A	N/A	DWS Contrast?	N/A
N/A	Landing Slope (%)	N/A	N/A	DWS Length (in)	N/A
N/A	Landing X Slope (%)	N/A	N/A	DWS Full Width?	N/A
N/A	Landing Curb? (Y/N)	N/A	N/A	DWS Offset (in)	N/A
N/A	Shared Landing?	N/A			
N/A	Gutter Ponding?	N/A	N/A	Gutter Slope (%)	N/A
N/A	Gutter Lip Ht (in)	N/A	N/A	Gutter X Slope (%)	N/A
N/A	Painted X Walk1?	No	N/A	Painted X Walk2?	No
	X Walk 1 Direction	To NW		X Walk 2 Direction	To SW
N/A	X Walk 1 Width (in)	N/A	N/A	X Walk 2 Width (in)	N/A
	X Walk 1 Slope (%)	5.6		X Walk 2 Slope (%)	11.9
	X Walk 1 X Slope (%)	5.1		X Walk 2 X Slope (%)	2.7

N/A	Ramp inside XWalk1?	N/A	N/A	Ramp inside XWalk2?	N/A
	Road Slope (%)	2.1	N/A	Clear Space?	N/A
	Road X Slope (%)	1.3	N/A	Clear Space to XWalk (in)	N/A
N/A	Any Obstructions?	N/A	N/A	Storm Grate/Utility Hazard?	N/A
	Obstruction Type			Storm Grate/Utility Type	
		N/A			N/A
			Yes	Surface Condition? (G/P)	Good

Possible Solutions:

Remove & Replace Curb Ramp With Two New Directional Ramps or Equivalent.
