# Access Compliance Report

## Public Rights-of-Way

### (Curb Ramps)

Intersection ID: 10041994	Main Street: WINDY_VALLEY_DR	Cross Street: N/A	Location: NW
ADA ID: 25F18155FDD8	Ramp Type: Perp	Initial Pass/Fail: Fail	Overall Compliance: No
Severity Score: 10			
Codes/Mitigation Info/Possible Solution		Field Measurements/Component Compliance

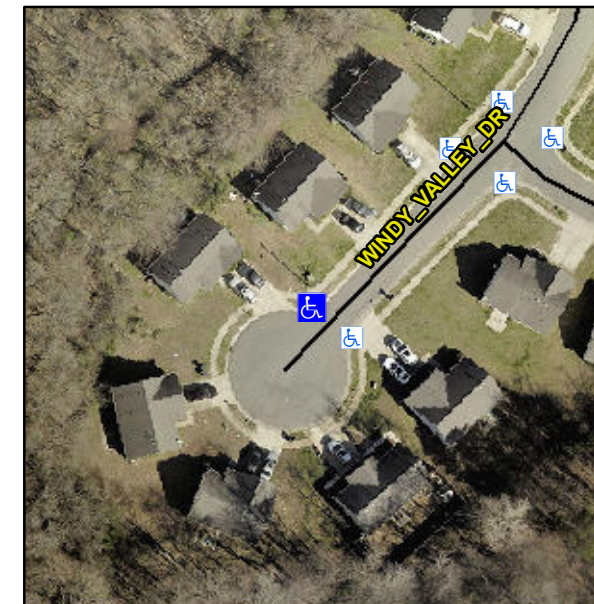
Compliance	Description	Data	Compliance	Description	Data
N/A	Ramp Length (in)	50.0	Yes	Ramp Slope (%)	7.9
No	Ramp Width (in)	45.0	No	Ramp XSlope (%)	2.1
N/A	Flare Type LT	N/A	N/A	Flare Type RT	N/A
N/A	Flare Slope LT (%)	N/A	N/A	Flare Slope RT (%)	N/A
N/A	Flare Traversable LT?	N/A	N/A	Flare Traversable RT?	N/A
N/A	Landing Length (in)	N/A	N/A	DWS Provided?	N/A
N/A	Landing Width (in)	N/A	N/A	DWS Contrast?	N/A
N/A	Landing Slope (%)	N/A	N/A	DWS Length (in)	N/A
N/A	Landing X Slope (%)	N/A	N/A	DWS Full Width?	N/A
N/A	Landing Curb? (Y/N)	N/A	N/A	DWS Offset (in)	N/A
N/A	Shared Landing?	N/A			
N/A	Gutter Ponding?	N/A	N/A	Gutter Slope (%)	N/A
N/A	Gutter Lip Ht (in)	N/A	N/A	Gutter X Slope (%)	N/A
N/A	Painted X Walk1?	No	N/A	Painted X Walk2?	N/A
	X Walk 1 Direction	To SE		X Walk 2 Direction	N/A
N/A	X Walk 1 Width (in)	N/A	N/A	X Walk 2 Width (in)	N/A
	X Walk 1 Slope (%)	2.9		X Walk 2 Slope (%)	N/A
	X Walk 1 X Slope (%)	0.1		X Walk 2 X Slope (%)	N/A

N/A	Ramp inside XWalk1?	N/A	N/A	Ramp inside XWalk2?	N/A
	Road Slope (%)	N/A	N/A	Clear Space?	N/A
	Road X Slope (%)	N/A	N/A	Clear Space to XWalk (in)	N/A
N/A	Any Obstructions?	N/A	N/A	Storm Grate/Utility Hazard?	N/A
	Obstruction Type			Storm Grate/Utility Type	
		N/A			N/A
			Yes	Surface Condition? (G/P)	Good

Possible Solutions:

**Remove & Replace Entire Ramp.**

**R304.5.1, R304.5.3**

Total Cost: \$ 1850.00
