# Access Compliance Report

## Public Rights-of-Way

| Intersection ID: 51054 | Main Street: MULBERRY_CHURCH_RD | Cross Street: N/A | Location: SE |
| ADA ID: 25F1F458C8E3 | Ramp Type: Perp | Initial Pass/Fail: Fail | Overall Compliance: No |

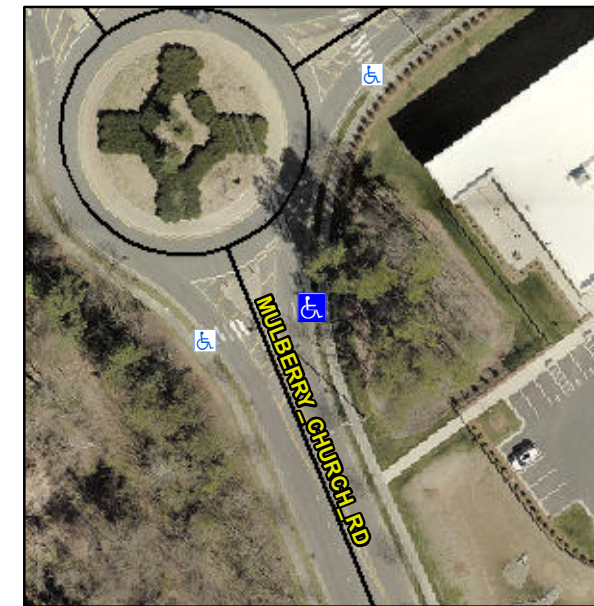
| | | Severity Score: 12.5 | |

**Not Found, R304.2.2**

| Compliance | Description | Data | Compliance | Description | Data |
|---|---|---|---|---|---|
| N/A | Ramp Length (in) | 48.0 | No | Ramp Slope (%) | 8.8 |

**Remove & Replace Entire Ramp.**

Total Cost: \$ 1850.00
