Access Compliance Report

Public Rights-of-Way

(Curb Ramps)

Intersection ID: N/A	Main Street: E TRADE ST	Cross Street: S BREVARD ST	Location:	N
ADA ID: 25F37663BDAF	Ramp Type: Perp	Initial Pass/Fail: Fail	Overall Compliance: No	Severity Score: 37.5
Codes/Mitigation Info/Possible Solution		Field Measurements/Component Compliance

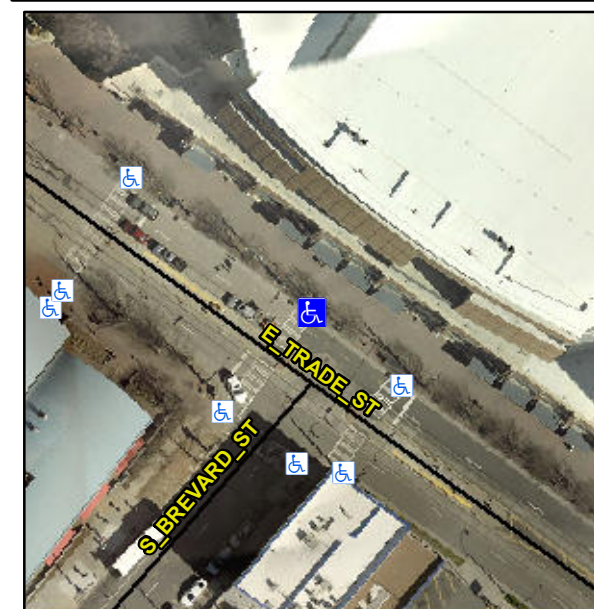
Not Found, R304.2.2, R304.5.3

Compliance	Description	Data	Compliance	Description	Data
N/A	Ramp Length (in)	90.0	No	Ramp Slope (%)	8.7
Yes	Ramp Width (in)	48.0	No	Ramp XSlope (%)	7.3
N/A	Flare Type LT	N/A	N/A	Flare Type RT	N/A
N/A	Flare Slope LT (%)	N/A	N/A	Flare Slope RT (%)	N/A
N/A	Flare Traversable LT?	No	N/A	Flare Traversable RT?	No
N/A	Landing Length (in)	N/A	N/A	DWS Provided?	N/A
N/A	Landing Width (in)	N/A	N/A	DWS Contrast?	N/A
N/A	Landing Slope (%)	N/A	N/A	DWS Length (in)	N/A
N/A	Landing X Slope (%)	N/A	N/A	DWS Full Width?	N/A
N/A	Landing Curb? (Y/N)	N/A	N/A	DWS Offset (in)	N/A
N/A	Shared Landing?	N/A			
N/A	Gutter Ponding?	N/A	N/A	Gutter Slope (%)	N/A
N/A	Gutter Lip Ht (in)	N/A	N/A	Gutter X Slope (%)	N/A
N/A	Painted X Walk1?	Yes	N/A	Painted X Walk2?	N/A
	X Walk 1 Direction	To SW		X Walk 2 Direction	N/A
N/A	X Walk 1 Width (in)	108.0	N/A	X Walk 2 Width (in)	N/A
	X Walk 1 Slope (%)	2.3		X Walk 2 Slope (%)	N/A
	X Walk 1 X Slope (%)	0.7		X Walk 2 X Slope (%)	N/A

N/A	Ramp inside XWalk1?	Yes	N/A	Ramp inside XWalk2?	N/A
	Road Slope (%)	N/A	N/A	Clear Space?	N/A
	Road X Slope (%)	N/A	N/A	Clear Space to XWalk (in)	N/A
N/A	Any Obstructions?	N/A	N/A	Storm Grate/Utility Hazard?	N/A
	Obstruction Type			Storm Grate/Utility Type	
		N/A			N/A
			Yes	Surface Condition? (G/P)	Good

Remove & Replace Entire Ramp.
