# Access Compliance Report

## Public Rights-of-Way

| Intersection ID: 13893 | Main Street: BUTTERNUT_CT | Cross Street: EUCLID_AV | Location: W |
| ADA ID: 25F9511DC9EA | Ramp Type: Directional1 | Initial Pass/Fail: Fail | Overall Compliance: No |

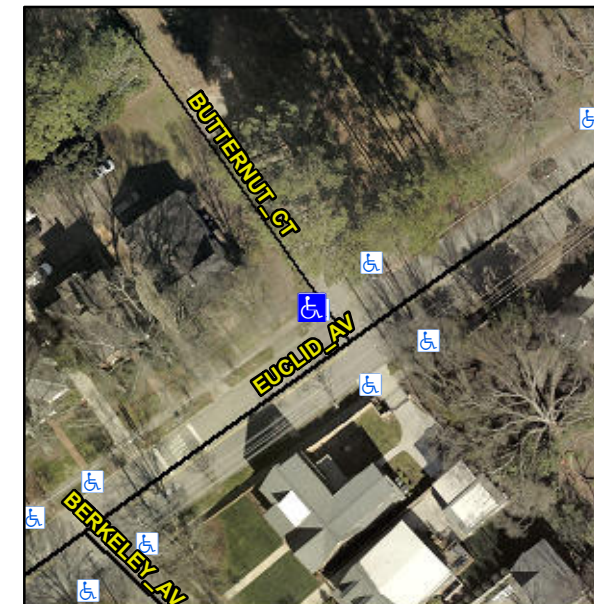
**R304.5.1, R304.2.2**

| Compliance | Description | Data | Compliance | Description | Data |
|---|---|---|---|---|---|
| No | Ramp Width (in) | 32.0 | N/A | Grade Break Slope (%) | 0.0 |
| No | Ramp Slope (%) | 22.1 | N/A | Grade Break XSlope (%) | 0.0 |

**Remove & Replace Entire Ramp.**
