# Access Compliance Report

## Public Rights-of-Way

### (Curb Ramps)

Intersection ID: 10337	Main Street: E_36TH_ST	Cross Street: SPENCER_ST	Location:	N
ADA ID: 2605F98AF2F6	Ramp Type: Perp	Initial Pass/Fail: Fail	Overall Compliance: No	Severity Score: 8.75
Codes/Mitigation Info/Possible Solution		Field Measurements/Component Compliance

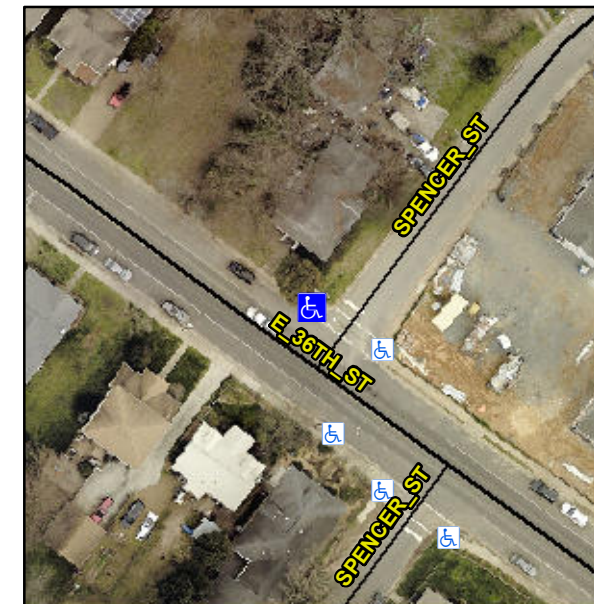
**Not Found, R304.5.1**

Compliance	Description	Data	Compliance	Description	Data
N/A	Ramp Length (in)	48.0	Yes	Ramp Slope (%)	5.0
No	Ramp Width (in)	47.5	Yes	Ramp XSlope (%)	1.8
N/A	Flare Type LT	N/A	N/A	Flare Type RT	N/A
N/A	Flare Slope LT (%)	N/A	N/A	Flare Slope RT (%)	N/A
N/A	Flare Traversable LT?	N/A	N/A	Flare Traversable RT?	N/A
N/A	Landing Length (in)	N/A	N/A	DWS Provided?	N/A
N/A	Landing Width (in)	N/A	N/A	DWS Contrast?	N/A
N/A	Landing Slope (%)	N/A	N/A	DWS Length (in)	N/A
N/A	Landing X Slope (%)	N/A	N/A	DWS Full Width?	N/A
N/A	Landing Curb? (Y/N)	N/A	N/A	DWS Offset (in)	N/A
N/A	Shared Landing?	N/A			
N/A	Gutter Ponding?	N/A	N/A	Gutter Slope (%)	N/A
N/A	Gutter Lip Ht (in)	N/A	N/A	Gutter X Slope (%)	N/A
N/A	Painted X Walk1?	Yes	N/A	Painted X Walk2?	N/A
	X Walk 1 Direction	To SE		X Walk 2 Direction	N/A
N/A	X Walk 1 Width (in)	112.0	N/A	X Walk 2 Width (in)	N/A
	X Walk 1 Slope (%)	1.7		X Walk 2 Slope (%)	N/A
	X Walk 1 X Slope (%)	1.8		X Walk 2 X Slope (%)	N/A

N/A	Ramp inside XWalk1?	Yes	N/A	Ramp inside XWalk2?	N/A
	Road Slope (%)	N/A	N/A	Clear Space?	N/A
	Road X Slope (%)	N/A	N/A	Clear Space to XWalk (in)	N/A
N/A	Any Obstructions?	N/A	N/A	Storm Grate/Utility Hazard?	N/A
	Obstruction Type			Storm Grate/Utility Type	
		N/A			N/A
			Yes	Surface Condition? (G/P)	Good

Possible Solutions:

**Remove & Replace Entire Ramp.**
