Access Compliance Report

Public Rights-of-Way

(Curb Ramps)

Intersection ID: 9962	Main Street: LITTLE ROCK RD	Cross Street: TUCKASEEGEE RD	Location:	N
ADA ID: 26068396B086	Ramp Type: BlendTrans1	Initial Pass/Fail: Fail	Overall Compliance: No	Severity Score: 8.75
Codes/Mitigation Info/Possible Solution		Field Measurements/Component Compliance

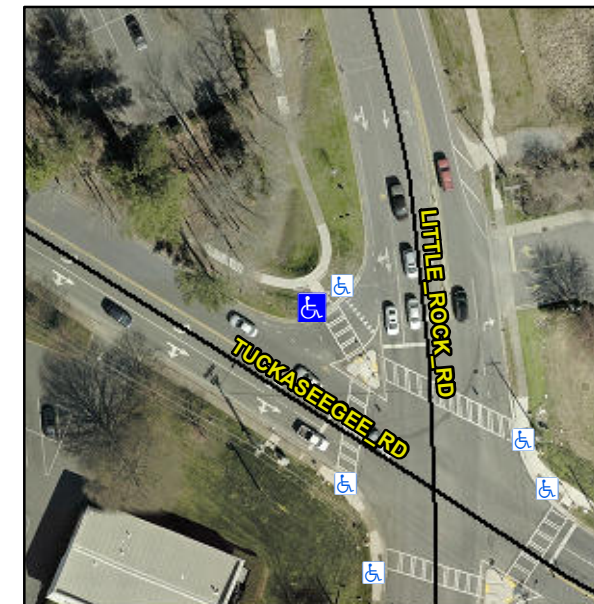
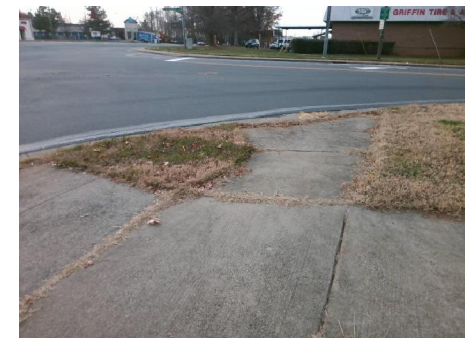
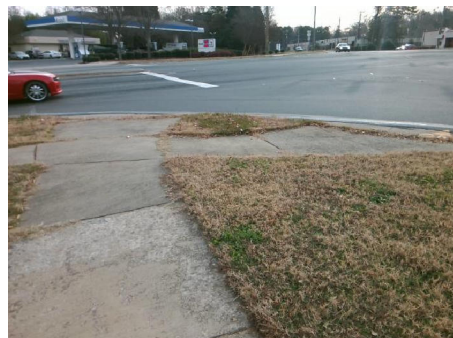
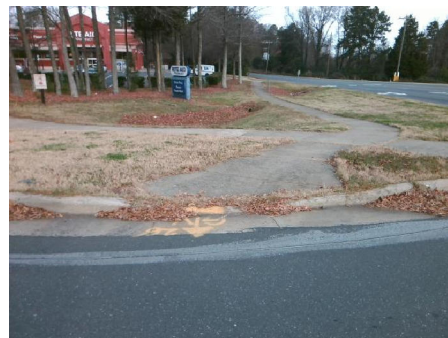
Not Found, R304.5.1

Compliance	Description	Data	Compliance	Description	Data
N/A	Ramp Length (in)	53.0	Yes	BlendTrans Slope (%)	2.3
No	Ramp Width (in)	47.0	Yes	BlendTrans XSlope (%)	0.9
N/A	Flare Type LT	N/A	N/A	Flare Type RT	N/A
N/A	Flare Slope LT (%)	N/A	N/A	Flare Slope RT (%)	N/A
N/A	Flare Traversable LT?	N/A	N/A	Flare Traversable RT?	N/A
N/A	Landing Length (in)	N/A	N/A	DWS Provided?	N/A
N/A	Landing Width (in)	N/A	N/A	DWS Contrast?	N/A
N/A	Landing Slope (%)	N/A	N/A	DWS Length (in)	N/A
N/A	Landing X Slope (%)	N/A	N/A	DWS Full Width?	N/A
N/A	Landing Curb? (Y/N)	N/A	N/A	DWS Offset (in)	N/A
N/A	Shared Landing?	N/A			
N/A	Gutter Ponding?	N/A	N/A	Gutter Slope (%)	N/A
N/A	Gutter Lip Ht (in)	N/A	N/A	Gutter X Slope (%)	N/A
N/A	Painted X Walk1?	No	N/A	Painted X Walk2?	N/A
	X Walk 1 Direction	To S		X Walk 2 Direction	N/A
	X Walk 1 Width (in)	N/A		X Walk 2 Width (in)	N/A
	X Walk 1 Slope (%)	1.8		X Walk 2 Slope (%)	N/A
	X Walk 1 X Slope (%)	1.8		X Walk 2 X Slope (%)	N/A

N/A	Ramp inside XWalk1?	N/A	N/A	Ramp inside XWalk2?	N/A
	Road Slope (%)	1.8		Clear Space?	N/A
	Road X Slope (%)	1.8	N/A	Clear Space to XWalk (in)	N/A
N/A	Any Obstructions?	N/A	N/A	Storm Grate/Utility Hazard?	N/A
	Obstruction Type			Storm Grate/Utility Type	
		N/A			N/A
			Yes	Surface Condition? (G/P)	Good
			No	Curb Slope (%)	15.1

Remove & Replace Curb Ramp With Two New Directional Ramps or Equivalent.
