# Access Compliance Report

## Public Rights-of-Way

### (Curb Ramps)

Intersection ID: 26409	Main Street: KUYKENDALL_RD	Cross Street: PROVIDENCE_RD	Location: SE
ADA ID: 260709757AC7	Ramp Type: Perp	Initial Pass/Fail: Fail	Overall Compliance: No
Severity Score: 33.75			
Codes/Mitigation Info/Possible Solution		Field Measurements/Component Compliance

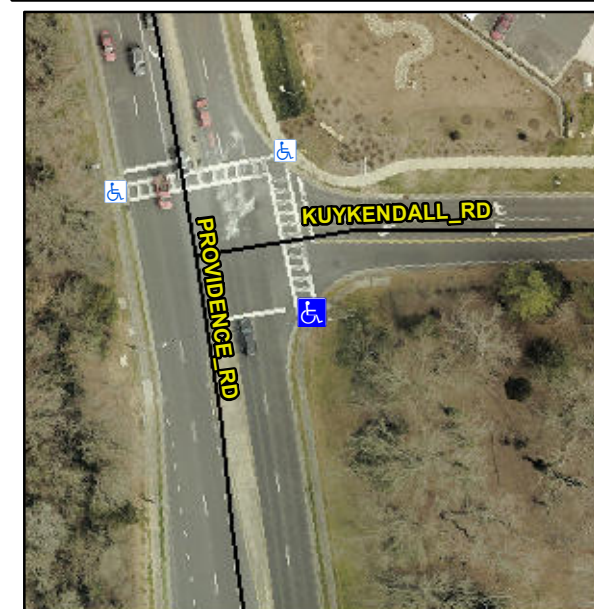
**Not Found, R304.5.1, R304.5.3**

Compliance	Description	Data	Compliance	Description	Data
N/A	Ramp Length (in)	81.0	Yes	Ramp Slope (%)	6.2
No	Ramp Width (in)	45.5	No	Ramp XSlope (%)	7.1
N/A	Flare Type LT	N/A	N/A	Flare Type RT	N/A
N/A	Flare Slope LT (%)	N/A	N/A	Flare Slope RT (%)	N/A
N/A	Flare Traversable LT?	N/A	N/A	Flare Traversable RT?	N/A
N/A	Landing Length (in)	N/A	N/A	DWS Provided?	N/A
N/A	Landing Width (in)	N/A	N/A	DWS Contrast?	N/A
N/A	Landing Slope (%)	N/A	N/A	DWS Length (in)	N/A
N/A	Landing X Slope (%)	N/A	N/A	DWS Full Width?	N/A
N/A	Landing Curb? (Y/N)	N/A	N/A	DWS Offset (in)	N/A
N/A	Shared Landing?	N/A			
N/A	Gutter Ponding?	N/A	N/A	Gutter Slope (%)	N/A
N/A	Gutter Lip Ht (in)	N/A	N/A	Gutter X Slope (%)	N/A
N/A	Painted X Walk1?	Yes	N/A	Painted X Walk2?	N/A
	X Walk 1 Direction	To N		X Walk 2 Direction	N/A
N/A	X Walk 1 Width (in)	90.0	N/A	X Walk 2 Width (in)	N/A
	X Walk 1 Slope (%)	1.2		X Walk 2 Slope (%)	N/A
	X Walk 1 X Slope (%)	6.5		X Walk 2 X Slope (%)	N/A

N/A	Ramp inside XWalk1?	Yes	N/A	Ramp inside XWalk2?	N/A
	Road Slope (%)	N/A	N/A	Clear Space?	N/A
	Road X Slope (%)	N/A	N/A	Clear Space to XWalk (in)	N/A
N/A	Any Obstructions?	N/A	N/A	Storm Grate/Utility Hazard?	N/A
	Obstruction Type			Storm Grate/Utility Type	
		N/A			N/A
		Yes		Surface Condition? (G/P)	Good

Possible Solutions:

**Remove & Replace Entire Ramp.**
