# Access Compliance Report

## Public Rights-of-Way

### (Curb Ramps)

| Intersection ID: 12162 | Main Street: ROBINSON_CHURCH_RD | Cross Street: MARKET_ST | Location: NE |

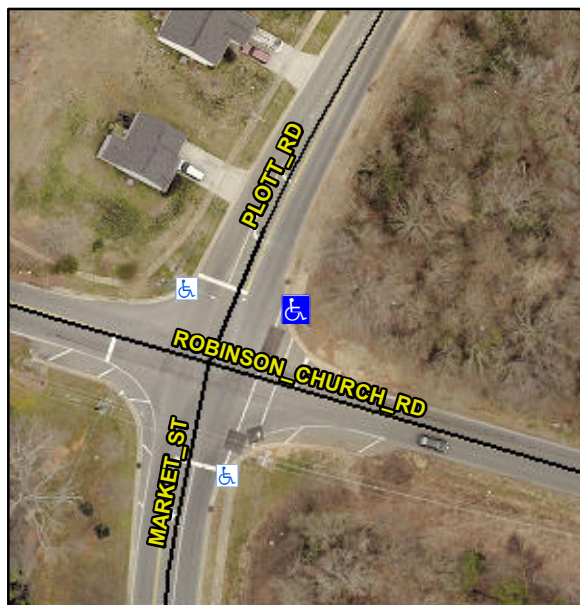
**Not Found, R304.2.2-Perp, R304.3.2-  
Para, R304.5.2, R305.1.4, R305.2,  
R302.7.2, R304.5.3**

| Compliance | Description | Data | Compliance | Description | Data |
|---|---|---|---|---|---|
| No | Landing Slope (%) | 3.0 | Yes | DWS Length (in) | 25.0 |
| Yes | Landing X Slope (%) | 0.3 | No | DWS Full Width? | No |
| No | Gutter Lip Ht (in) | 0.3 | No | Gutter X Slope (%) | 2.8 |

Possible Solutions:

**Remove & Replace Entire Ramp.  
Remove & Replace Gutter.**
