Access Compliance Report

Public Rights-of-Way

(Curb Ramps)

Intersection ID: N/A	Main Street: MATTHEWS_FARM_LN	Cross Street: N/A	Location: NW
ADA ID: 260EADC9181D	Ramp Type: Perp	Initial Pass/Fail: Fail	Overall Compliance: No
Severity Score: 13.75			
Codes/Mitigation Info/Possible Solution		Field Measurements/Component Compliance

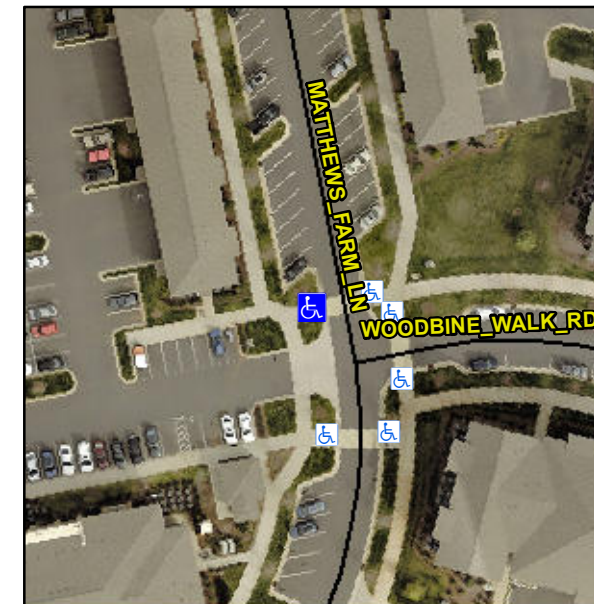
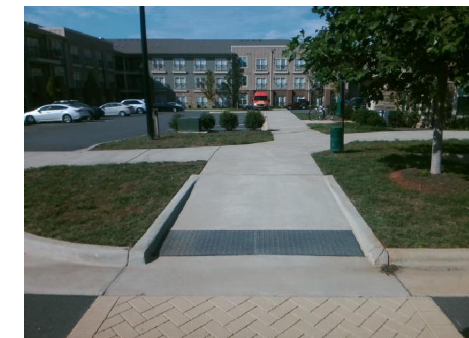
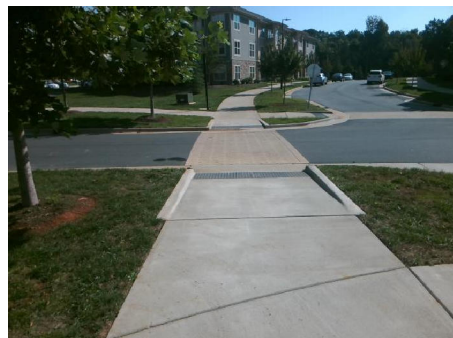
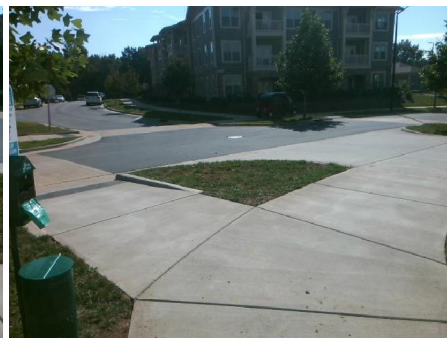
Compliance	Description	Data	Compliance	Description	Data
N/A	Ramp Length (in)	120.0	No	Ramp Slope (%)	9.7
Yes	Ramp Width (in)	93.0	No	Ramp XSlope (%)	2.6
N/A	Flare Type LT	N/A	N/A	Flare Type RT	N/A
N/A	Flare Slope LT (%)	N/A	N/A	Flare Slope RT (%)	N/A
N/A	Flare Traversable LT?	N/A	N/A	Flare Traversable RT?	N/A
N/A	Landing Length (in)	N/A	N/A	DWS Provided?	N/A
N/A	Landing Width (in)	N/A	N/A	DWS Contrast?	N/A
N/A	Landing Slope (%)	N/A	N/A	DWS Length (in)	N/A
N/A	Landing X Slope (%)	N/A	N/A	DWS Full Width?	N/A
N/A	Landing Curb? (Y/N)	N/A	N/A	DWS Offset (in)	N/A
N/A	Shared Landing?	N/A			
N/A	Gutter Ponding?	N/A	N/A	Gutter Slope (%)	N/A
N/A	Gutter Lip Ht (in)	N/A	N/A	Gutter X Slope (%)	N/A
N/A	Painted X Walk1?	No	N/A	Painted X Walk2?	N/A
	X Walk 1 Direction	To E		X Walk 2 Direction	N/A
N/A	X Walk 1 Width (in)	N/A	N/A	X Walk 2 Width (in)	N/A
	X Walk 1 Slope (%)	0.7		X Walk 2 Slope (%)	N/A
	X Walk 1 X Slope (%)	2.0		X Walk 2 X Slope (%)	N/A

N/A	Ramp inside XWalk1?	N/A	N/A	Ramp inside XWalk2?	N/A
	Road Slope (%)	N/A	N/A	Clear Space?	N/A
	Road X Slope (%)	N/A	N/A	Clear Space to XWalk (in)	N/A
N/A	Any Obstructions?	N/A	N/A	Storm Grate/Utility Hazard?	N/A
	Obstruction Type			Storm Grate/Utility Type	
		N/A			N/A
			Yes	Surface Condition? (G/P)	Good

Remove & Replace Entire Ramp.

R304.2.2, R304.5.3
