Access Compliance Report

Public Rights-of-Way

(Curb Ramps)

Intersection ID: 23499	Main Street: ALEXANDER_RD	Cross Street: BROOKFIELD_PL	Location: NE
ADA ID: 260F320B4231	Ramp Type: Directional1	Initial Pass/Fail: Fail	Overall Compliance: No
		Severity Score: 1.25

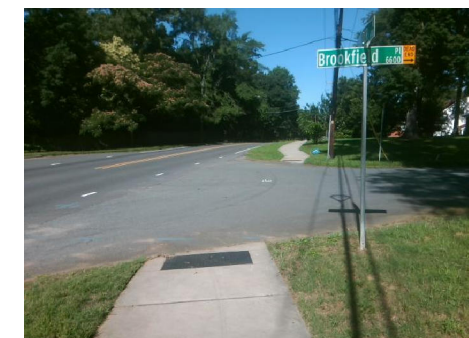
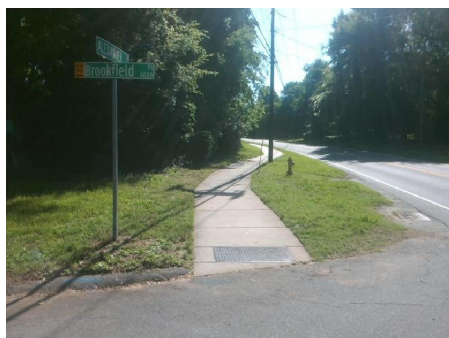
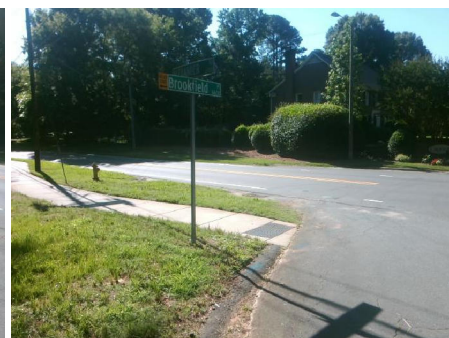
Compliance	Description	Data	Compliance	Description	Data
N/A	Ramp Length (in)	40.0	N/A	Grade Break?	N/A
Yes	Ramp Width (in)	72.0	N/A	Grade Break Slope (%)	0.0
Yes	Ramp Slope (%)	5.1	N/A	Grade Break XSlope (%)	0.0
No	Ramp XSlope (%)	4.9			
N/A	Flare Type LT	N/A	N/A	Flare Type RT	N/A
N/A	Flare Slope LT (%)	N/A	N/A	Flare Slope RT (%)	0.0
N/A	Flare Traversable LT?	N/A	N/A	Flare Traversable RT?	N/A
N/A	Landing Length (in)	0.0	N/A	DWS Provided?	N/A
N/A	Landing Width (in)	0.0	N/A	DWS Contrast?	N/A
N/A	Landing Slope (%)	0.0	N/A	DWS Length (in)	N/A
N/A	Landing X Slope (%)	0.0	N/A	DWS Full Width?	N/A
N/A	Landing Curb? (Y/N)	N/A	N/A	DWS Offset LT (in)	N/A
N/A	Shared Landing?	N/A	N/A	DWS Offset RT (in)	N/A
N/A	Gutter Ponding?	0.0	N/A	Gutter Slope (%)	N/A
N/A	Gutter Lip Ht (in)	0.0	N/A	Gutter X Slope (%)	N/A
N/A	Painted X Walk1?	No		Road Slope (%)	2.9
	X Walk 1 Direction	To W		Road X Slope (%)	2.8
	X Walk 1 Width (in)	N/A		Clear Space?	N/A

X Walk 1 Slope (%)	2.9	N/A	Clear Space to XWalk (in)	N/A
	X Walk 1 X Slope (%)	2.8	N/A	Storm Grate/Utility Hazard?	N/A
N/A	Ramp inside XWalk1?	N/A		Storm Grate/Utility Type	
N/A	Any Obstructions?	N/A			N/A
	Obstruction Type		Yes	Surface Condition? (G/P)	Good
			N/A	Curb Slope (%)	0.9

Remove & Replace Entire Ramp.

Total Cost: \$ 1600.00
