# Access Compliance Report

## Public Rights-of-Way

| Intersection ID: 28187 | Main Street: LINDRICK_LN | Cross Street: SAUNTON_CT | Location: SE |
| ADA ID: 261836CB8B28 | Ramp Type: BlendTrans2 | Initial Pass/Fail: Pass | Overall Compliance: No |

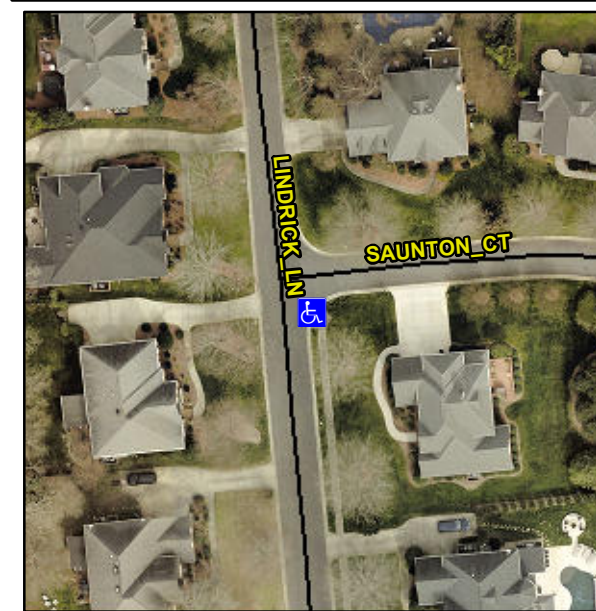
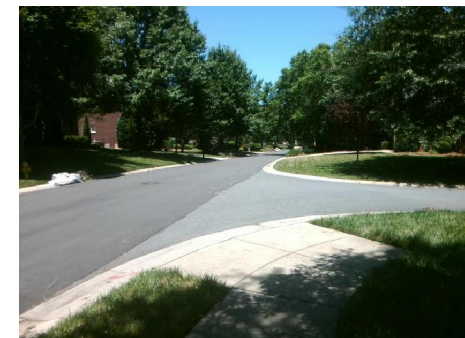
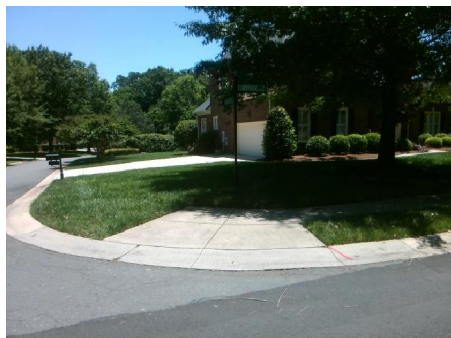
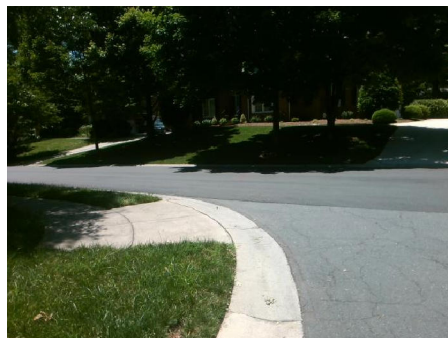
| Compliance | Description | Data | Compliance | Description | Data |
|---|---|---|---|---|---|
| N/A | Landing Length (in) | N/A | No | DWS Provided? | No |
| No | Gutter Lip Ht (in) | 0.3 | Yes | Gutter X Slope (%) | 0.7 |
| | | | No | Curb Slope (%) | 14.3 |

**Remove & Replace Curb Ramp With Two New Directional Ramps or Equivalent.**

**Not Found, R305, R302.7.2**
