Access Compliance Report

Public Rights-of-Way

(Curb Ramps)

Intersection ID: 15632	Main Street: EXECUTIVE_CENTER_DR	Cross Street: FARM_POND_LN	Location: NW
ADA ID: 2618D830A453	Ramp Type: PerpDiag	Initial Pass/Fail: Fail	Overall Compliance: No
Severity Score: 21.25			
Codes/Mitigation Info/Possible Solution		Field Measurements/Component Compliance

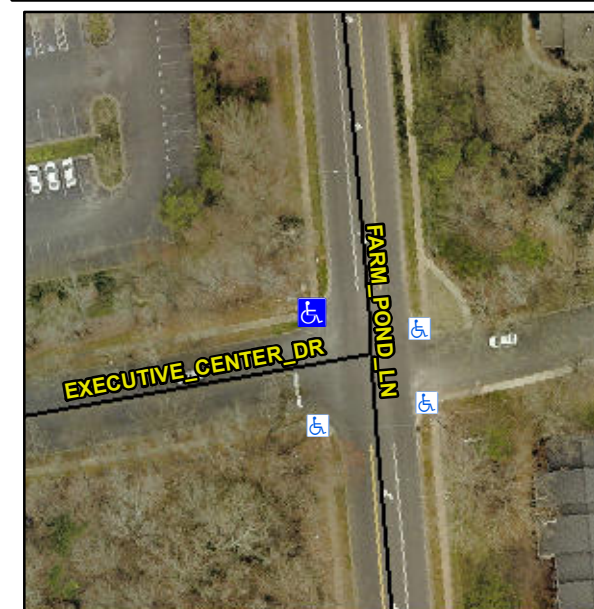
Not Found, R304.5.1, R304.2.2

Compliance	Description	Data	Compliance	Description	Data
N/A	Ramp Length (in)	30.0	No	Ramp Slope (%)	11.1
No	Ramp Width (in)	36.0	Yes	Ramp XSlope (%)	0.1
N/A	Flare Type LT	N/A	N/A	Flare Type RT	N/A
N/A	Flare Slope LT (%)	N/A	N/A	Flare Slope RT (%)	N/A
N/A	Flare Traversable LT?	N/A	N/A	Flare Traversable RT?	N/A
N/A	Landing Length (in)	N/A	N/A	DWS Provided?	N/A
N/A	Landing Width (in)	N/A	N/A	DWS Contrast?	N/A
N/A	Landing Slope (%)	N/A	N/A	DWS Length (in)	N/A
N/A	Landing X Slope (%)	N/A	N/A	DWS Full Width?	N/A
N/A	Landing Curb? (Y/N)	N/A	N/A	DWS Offset (in)	N/A
N/A	Shared Landing?	N/A			
N/A	Gutter Ponding?	N/A	N/A	Gutter Slope (%)	N/A
N/A	Gutter Lip Ht (in)	N/A	N/A	Gutter X Slope (%)	N/A
N/A	Painted X Walk1?	No	N/A	Painted X Walk2?	No
	X Walk 1 Direction	To S		X Walk 2 Direction	To E
N/A	X Walk 1 Width (in)	N/A	N/A	X Walk 2 Width (in)	N/A
	X Walk 1 Slope (%)	4.2		X Walk 2 Slope (%)	5.5
	X Walk 1 X Slope (%)	4.5		X Walk 2 X Slope (%)	0.2

N/A	Ramp inside XWalk1?	N/A	N/A	Ramp inside XWalk2?	N/A
	Road Slope (%)	2.6	N/A	Clear Space?	N/A
	Road X Slope (%)	6.5	N/A	Clear Space to XWalk (in)	N/A
N/A	Any Obstructions?	N/A	N/A	Storm Grate/Utility Hazard?	N/A
	Obstruction Type			Storm Grate/Utility Type	
		N/A			N/A
			Yes	Surface Condition? (G/P)	Good

Possible Solutions:

Remove & Replace Curb Ramp With Two New Directional Ramps or Equivalent.
