Access Compliance Report

Public Rights-of-Way

(Curb Ramps)

Intersection ID: N/A	Main Street: MARGIE_ANN_DR	Cross Street: ARLYN_CIR	Location: S
ADA ID: 261E8E93463E	Ramp Type: Perp	Initial Pass/Fail: Pass	Overall Compliance: No
Severity Score: 0.25			
Codes/Mitigation Info/Possible Solution		Field Measurements/Component Compliance

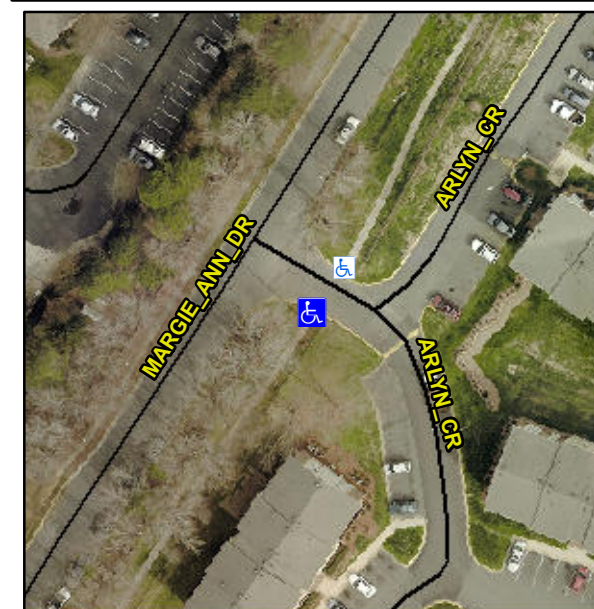
Not Found, R304.5.3

Compliance	Description	Data	Compliance	Description	Data
N/A	Ramp Length (in)	59.0	Yes	Ramp Slope (%)	5.9
Yes	Ramp Width (in)	50.0	No	Ramp XSlope (%)	2.4
N/A	Flare Type LT	Sloped	N/A	Flare Type RT	N/A
N/A	Flare Slope LT (%)	17.1	N/A	Flare Slope RT (%)	10.7
N/A	Flare Traversable LT?	No	N/A	Flare Traversable RT?	No
Yes	Landing Length (in)	73.0	Yes	DWS Provided?	Yes
Yes	Landing Width (in)	48.0	Yes	DWS Contrast?	Yes
Yes	Landing Slope (%)	1.5	Yes	DWS Length (in)	24.0
Yes	Landing X Slope (%)	0.8	Yes	DWS Full Width?	Yes
N/A	Landing Curb? (Y/N)	No	Yes	DWS Offset (in)	1.0
N/A	Shared Landing?	No			
Yes	Gutter Ponding?	No	Yes	Gutter Slope (%)	2.3
Yes	Gutter Lip Ht (in)	0.0	Yes	Gutter X Slope (%)	0.1
N/A	Painted X Walk1?	No	N/A	Painted X Walk2?	N/A
	X Walk 1 Direction	To NE		X Walk 2 Direction	N/A
N/A	X Walk 1 Width (in)	N/A	N/A	X Walk 2 Width (in)	N/A
	X Walk 1 Slope (%)	1.7		X Walk 2 Slope (%)	N/A
	X Walk 1 X Slope (%)	1.0		X Walk 2 X Slope (%)	N/A

N/A	Ramp inside XWalk1?	N/A	N/A	Ramp inside XWalk2?	N/A
	Road Slope (%)	N/A	N/A	Clear Space?	Yes
	Road X Slope (%)	N/A	N/A	Clear Space to XWalk (in)	N/A
Yes	Any Obstructions?	No	Yes	Storm Grate/Utility Hazard?	No
	Obstruction Type			Storm Grate/Utility Type	
		N/A			N/A
			Yes	Surface Condition? (G/P)	Good

Possible Solutions:

Remove & Replace Entire Ramp.
