# Access Compliance Report

## Public Rights-of-Way

### (Curb Ramps)

Intersection ID: 10029119	Main Street: JAMES_BLAKENEY_AV	Cross Street: N/A	Location: NW
ADA ID: 2621752D5ABE	Ramp Type: PerpDiag	Initial Pass/Fail: Fail	Overall Compliance: No
Severity Score: 33.75			
Codes/Mitigation Info/Possible Solution		Field Measurements/Component Compliance

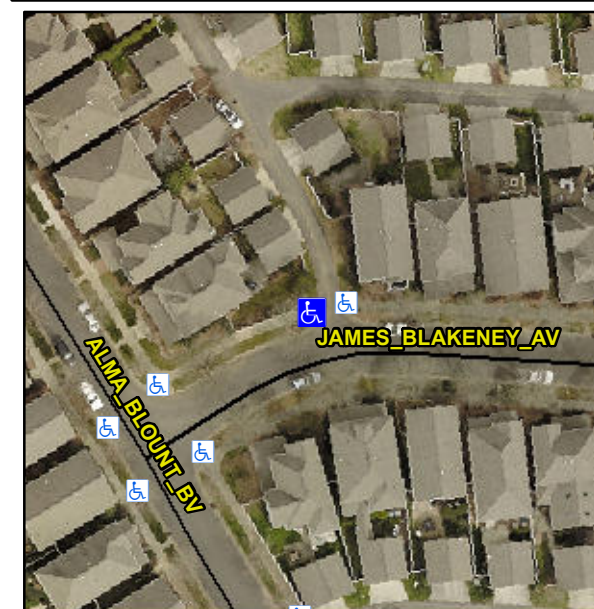
Compliance	Description	Data	Compliance	Description	Data
N/A	Ramp Length (in)	67.0	No	Ramp Slope (%)	12.1
No	Ramp Width (in)	40.0	Yes	Ramp XSlope (%)	0.5
N/A	Flare Type LT	N/A	N/A	Flare Type RT	N/A
N/A	Flare Slope LT (%)	N/A	N/A	Flare Slope RT (%)	N/A
N/A	Flare Traversable LT?	N/A	N/A	Flare Traversable RT?	N/A
N/A	Landing Length (in)	N/A	N/A	DWS Provided?	N/A
N/A	Landing Width (in)	N/A	N/A	DWS Contrast?	N/A
N/A	Landing Slope (%)	N/A	N/A	DWS Length (in)	N/A
N/A	Landing X Slope (%)	N/A	N/A	DWS Full Width?	N/A
N/A	Landing Curb? (Y/N)	N/A	N/A	DWS Offset (in)	N/A
N/A	Shared Landing?	N/A			
N/A	Gutter Ponding?	N/A	N/A	Gutter Slope (%)	N/A
N/A	Gutter Lip Ht (in)	N/A	N/A	Gutter X Slope (%)	N/A
N/A	Painted X Walk1?	No	N/A	Painted X Walk2?	No
	X Walk 1 Direction	To S		X Walk 2 Direction	To E
N/A	X Walk 1 Width (in)	N/A	N/A	X Walk 2 Width (in)	N/A
	X Walk 1 Slope (%)	0.7		X Walk 2 Slope (%)	0.4
	X Walk 1 X Slope (%)	1.0		X Walk 2 X Slope (%)	1.6

N/A	Ramp inside XWalk1?	N/A	N/A	Ramp inside XWalk2?	N/A
	Road Slope (%)	0.4	N/A	Clear Space?	N/A
	Road X Slope (%)	1.3	N/A	Clear Space to XWalk (in)	N/A
N/A	Any Obstructions?	N/A	N/A	Storm Grate/Utility Hazard?	N/A
	Obstruction Type			Storm Grate/Utility Type	
		N/A			N/A
			Yes	Surface Condition? (G/P)	Good

Possible Solutions:

**Remove & Replace Curb Ramp With Two New Directional Ramps or Equivalent.**

**R304.5.1, R304.2.2**
