Access Compliance Report

Public Rights-of-Way

(Curb Ramps)

Intersection ID: 22146	Main Street: E_HEBRON_ST	Cross Street: NATIONS_FORD_RD	Location: SE
ADA ID: 262ED5AD01C9	Ramp Type: PerpDiag	Initial Pass/Fail: Fail	Overall Compliance: No
Severity Score: 33.75			
Codes/Mitigation Info/Possible Solution		Field Measurements/Component Compliance

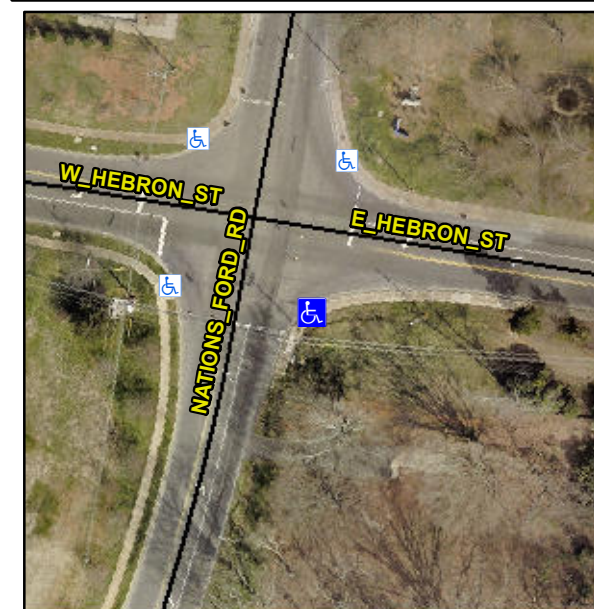
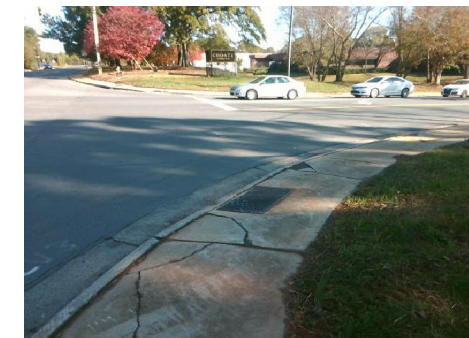
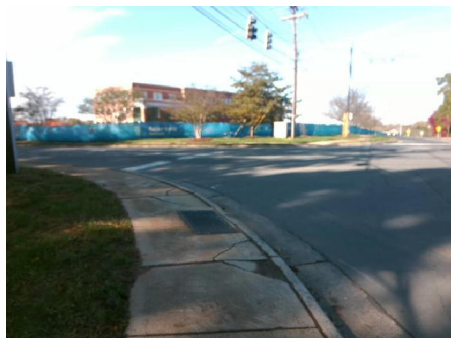
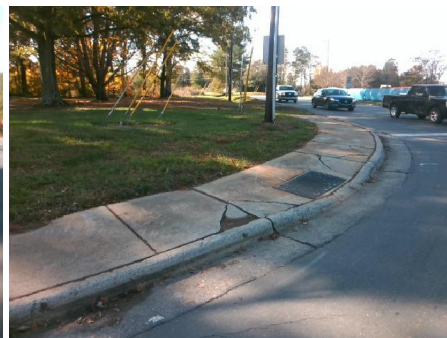
Not Found, R304.5.1, R304.2.2, R304.5.3

Compliance	Description	Data	Compliance	Description	Data
N/A	Ramp Length (in)	60.0	No	Ramp Slope (%)	9.1
No	Ramp Width (in)	46.0	No	Ramp XSlope (%)	6.7
N/A	Flare Type LT	N/A	N/A	Flare Type RT	N/A
N/A	Flare Slope LT (%)	N/A	N/A	Flare Slope RT (%)	N/A
N/A	Flare Traversable LT?	N/A	N/A	Flare Traversable RT?	N/A
N/A	Landing Length (in)	N/A	N/A	DWS Provided?	N/A
N/A	Landing Width (in)	N/A	N/A	DWS Contrast?	N/A
N/A	Landing Slope (%)	N/A	N/A	DWS Length (in)	N/A
N/A	Landing X Slope (%)	N/A	N/A	DWS Full Width?	N/A
N/A	Landing Curb? (Y/N)	N/A	N/A	DWS Offset (in)	N/A
N/A	Shared Landing?	N/A			
N/A	Gutter Ponding?	N/A	N/A	Gutter Slope (%)	N/A
N/A	Gutter Lip Ht (in)	N/A	N/A	Gutter X Slope (%)	N/A
N/A	Painted X Walk1?	No	N/A	Painted X Walk2?	No
	X Walk 1 Direction	To NE		X Walk 2 Direction	To NW
N/A	X Walk 1 Width (in)	N/A	N/A	X Walk 2 Width (in)	N/A
	X Walk 1 Slope (%)	0.5		X Walk 2 Slope (%)	5.6
	X Walk 1 X Slope (%)	6.1		X Walk 2 X Slope (%)	0.7

N/A	Ramp inside XWalk1?	N/A	N/A	Ramp inside XWalk2?	N/A
	Road Slope (%)	3.4	N/A	Clear Space?	N/A
	Road X Slope (%)	5.1	N/A	Clear Space to XWalk (in)	N/A
N/A	Any Obstructions?	N/A	N/A	Storm Grate/Utility Hazard?	N/A
	Obstruction Type			Storm Grate/Utility Type	
		N/A			N/A
			Yes	Surface Condition? (G/P)	Good

Remove & Replace Curb Ramp With Two New Directional Ramps or Equivalent.
