Access Compliance Report

Public Rights-of-Way

(Curb Ramps)

Intersection ID: 31563	Main Street: DORIS_RAY_CT	Cross Street: MCCORD_ST	Location: NE
ADA ID: 2631A56D1F8A	Ramp Type: BlendTrans1	Initial Pass/Fail: Fail	Overall Compliance: No
		Severity Score: 10

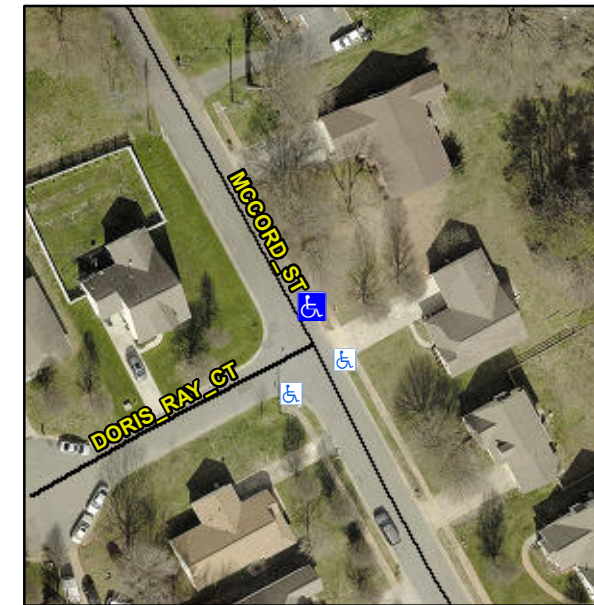
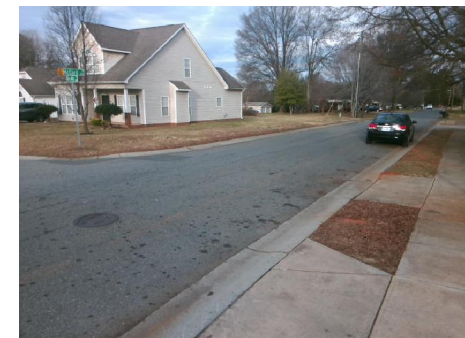
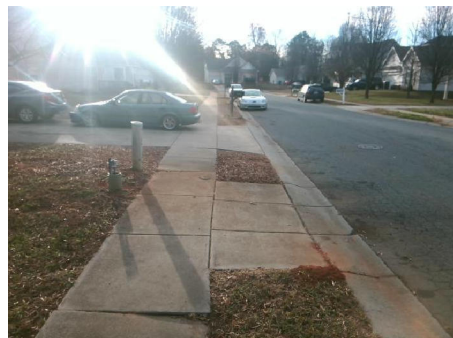
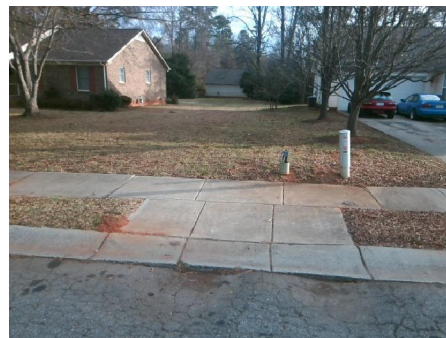
Compliance	Description	Data	Compliance	Description	Data
N/A	Ramp Length (in)	47.5	Yes	BlendTrans Slope (%)	3.3
No	Ramp Width (in)	41.5	No	BlendTrans XSlope (%)	2.1
N/A	Flare Type LT	N/A	N/A	Flare Type RT	N/A
N/A	Flare Slope LT (%)	N/A	N/A	Flare Slope RT (%)	N/A
N/A	Flare Traversable LT?	N/A	N/A	Flare Traversable RT?	N/A
N/A	Landing Length (in)	N/A	N/A	DWS Provided?	N/A
N/A	Landing Width (in)	N/A	N/A	DWS Contrast?	N/A
N/A	Landing Slope (%)	N/A	N/A	DWS Length (in)	N/A
N/A	Landing X Slope (%)	N/A	N/A	DWS Full Width?	N/A
N/A	Landing Curb? (Y/N)	N/A	N/A	DWS Offset (in)	N/A
N/A	Shared Landing?	N/A			
N/A	Gutter Ponding?	N/A	N/A	Gutter Slope (%)	N/A
N/A	Gutter Lip Ht (in)	3.0	N/A	Gutter X Slope (%)	N/A
N/A	Painted X Walk1?	No	N/A	Painted X Walk2?	N/A
	X Walk 1 Direction	To W		X Walk 2 Direction	N/A
	X Walk 1 Width (in)	N/A		X Walk 2 Width (in)	N/A
	X Walk 1 Slope (%)	1.6		X Walk 2 Slope (%)	N/A
	X Walk 1 X Slope (%)	1.7		X Walk 2 X Slope (%)	N/A

N/A	Ramp inside XWalk1?	N/A	N/A	Ramp inside XWalk2?	N/A
	Road Slope (%)	1.7		Clear Space?	N/A
	Road X Slope (%)	1.6	N/A	Clear Space to XWalk (in)	N/A
N/A	Any Obstructions?	N/A	N/A	Storm Grate/Utility Hazard?	N/A
	Obstruction Type			Storm Grate/Utility Type	
		N/A			N/A
			Yes	Surface Condition? (G/P)	Good
			N/A	Curb Slope (%)	4.7

Remove & Replace Curb Ramp With Two New Directional Ramps or Equivalent.

R304.5.1, R304.5.3
