# Access Compliance Report

## Public Rights-of-Way

### (Curb Ramps)

Intersection ID: N/A	Main Street: KELYN_HILLS_DR	Cross Street: KINLEY_COMMONS_LN	Location: SW
ADA ID: 263C1B745C41	Ramp Type: Perp	Initial Pass/Fail: Fail	Overall Compliance: No
Severity Score: 8.75			
Codes/Mitigation Info/Possible Solution		Field Measurements/Component Compliance

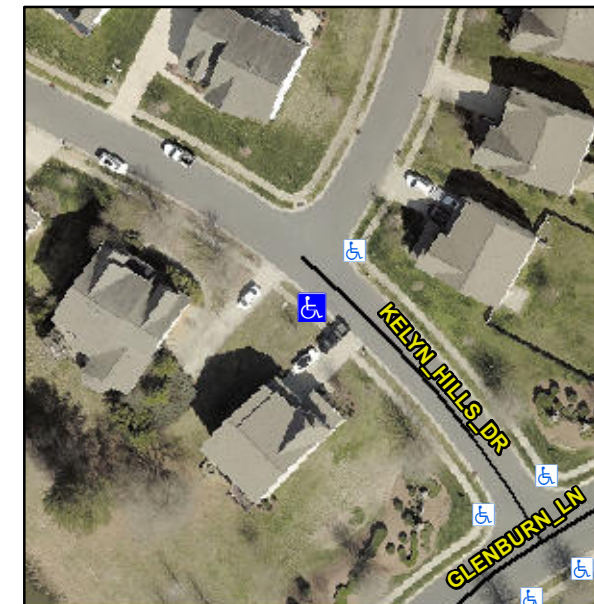
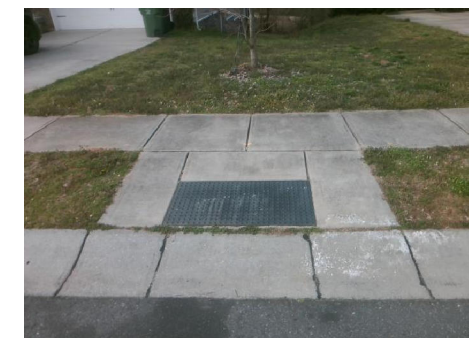
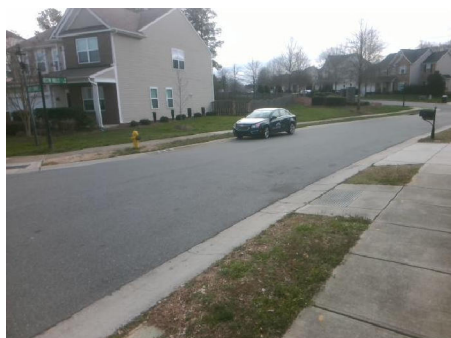
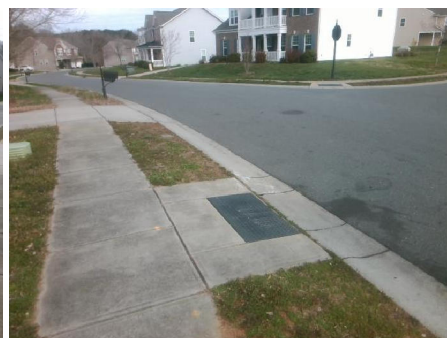
**Not Found, R304.5.1**

Compliance	Description	Data	Compliance	Description	Data
N/A	Ramp Length (in)	48.0	Yes	Ramp Slope (%)	6.0
No	Ramp Width (in)	43.0	Yes	Ramp XSlope (%)	0.3
N/A	Flare Type LT	N/A	N/A	Flare Type RT	N/A
N/A	Flare Slope LT (%)	N/A	N/A	Flare Slope RT (%)	N/A
N/A	Flare Traversable LT?	N/A	N/A	Flare Traversable RT?	N/A
N/A	Landing Length (in)	N/A	N/A	DWS Provided?	N/A
N/A	Landing Width (in)	N/A	N/A	DWS Contrast?	N/A
N/A	Landing Slope (%)	N/A	N/A	DWS Length (in)	N/A
N/A	Landing X Slope (%)	N/A	N/A	DWS Full Width?	N/A
N/A	Landing Curb? (Y/N)	N/A	N/A	DWS Offset (in)	N/A
N/A	Shared Landing?	N/A			
N/A	Gutter Ponding?	N/A	N/A	Gutter Slope (%)	N/A
N/A	Gutter Lip Ht (in)	N/A	N/A	Gutter X Slope (%)	N/A
N/A	Painted X Walk1?	No	N/A	Painted X Walk2?	N/A
	X Walk 1 Direction	To NE		X Walk 2 Direction	N/A
N/A	X Walk 1 Width (in)	N/A	N/A	X Walk 2 Width (in)	N/A
	X Walk 1 Slope (%)	3.2		X Walk 2 Slope (%)	N/A
	X Walk 1 X Slope (%)	1.0		X Walk 2 X Slope (%)	N/A

N/A	Ramp inside XWalk1?	N/A	N/A	Ramp inside XWalk2?	N/A
	Road Slope (%)	N/A	N/A	Clear Space?	N/A
	Road X Slope (%)	N/A	N/A	Clear Space to XWalk (in)	N/A
N/A	Any Obstructions?	N/A	N/A	Storm Grate/Utility Hazard?	N/A
	Obstruction Type			Storm Grate/Utility Type	
		N/A			N/A
			Yes	Surface Condition? (G/P)	Good

**Remove & Replace Entire Ramp.**

**\$ 1850.00**
