Access Compliance Report

Public Rights-of-Way

(Curb Ramps)

Intersection ID: 21011	Main Street: CORONATION_BV	Cross Street: SARDIS_RD_NORTH	Location: SW
ADA ID: 264CA97189AB	Ramp Type: Perp	Initial Pass/Fail: Fail	Overall Compliance: No
Severity Score: 37.5			
Codes/Mitigation Info/Possible Solution		Field Measurements/Component Compliance

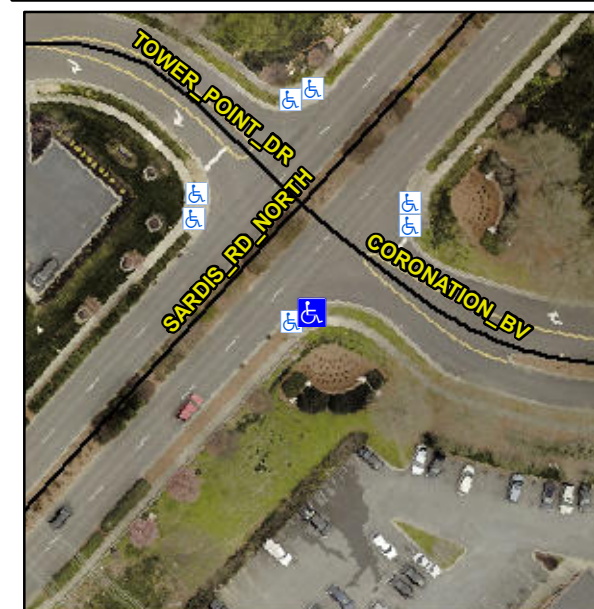
Not Found, R304.2.2, R304.5.3

Compliance	Description	Data	Compliance	Description	Data
N/A	Ramp Length (in)	66.0	No	Ramp Slope (%)	9.0
Yes	Ramp Width (in)	48.0	No	Ramp XSlope (%)	8.5
N/A	Flare Type LT	N/A	N/A	Flare Type RT	N/A
N/A	Flare Slope LT (%)	N/A	N/A	Flare Slope RT (%)	N/A
N/A	Flare Traversable LT?	N/A	N/A	Flare Traversable RT?	N/A
N/A	Landing Length (in)	N/A	N/A	DWS Provided?	N/A
N/A	Landing Width (in)	N/A	N/A	DWS Contrast?	N/A
N/A	Landing Slope (%)	N/A	N/A	DWS Length (in)	N/A
N/A	Landing X Slope (%)	N/A	N/A	DWS Full Width?	N/A
N/A	Landing Curb? (Y/N)	N/A	N/A	DWS Offset (in)	N/A
N/A	Shared Landing?	N/A			
N/A	Gutter Ponding?	N/A	N/A	Gutter Slope (%)	N/A
N/A	Gutter Lip Ht (in)	N/A	N/A	Gutter X Slope (%)	N/A
N/A	Painted X Walk1?	No	N/A	Painted X Walk2?	N/A
	X Walk 1 Direction	To NE		X Walk 2 Direction	N/A
N/A	X Walk 1 Width (in)	N/A	N/A	X Walk 2 Width (in)	N/A
	X Walk 1 Slope (%)	7.2		X Walk 2 Slope (%)	N/A
	X Walk 1 X Slope (%)	1.1		X Walk 2 X Slope (%)	N/A

N/A	Ramp inside XWalk1?	N/A	N/A	Ramp inside XWalk2?	N/A
	Road Slope (%)	N/A	N/A	Clear Space?	N/A
	Road X Slope (%)	N/A	N/A	Clear Space to XWalk (in)	N/A
N/A	Any Obstructions?	N/A	N/A	Storm Grate/Utility Hazard?	N/A
	Obstruction Type			Storm Grate/Utility Type	
		N/A			N/A
			Yes	Surface Condition? (G/P)	Good

Possible Solutions:

Remove & Replace Entire Ramp.
