Access Compliance Report

Public Rights-of-Way

(Curb Ramps)

Intersection ID: 10013252	Main Street: CRAIGHEAD_RD	Cross Street: N/A	Location: S
ADA ID: 2656919A3102	Ramp Type: BlendTrans1	Initial Pass/Fail: Fail	Overall Compliance: No
Severity Score: 12.5			
Codes/Mitigation Info/Possible Solution		Field Measurements/Component Compliance

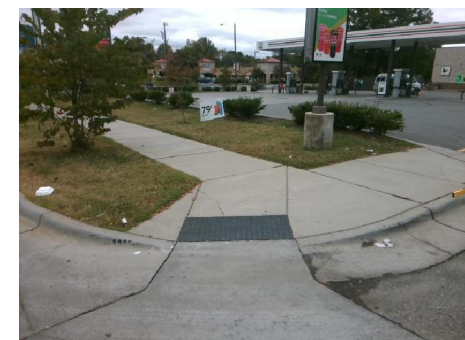
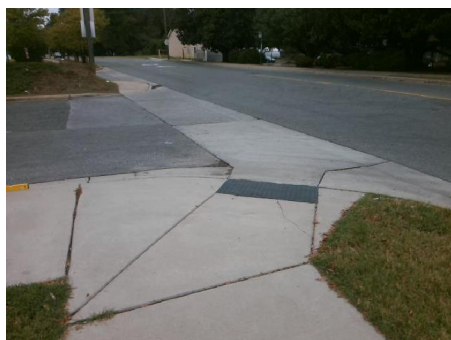
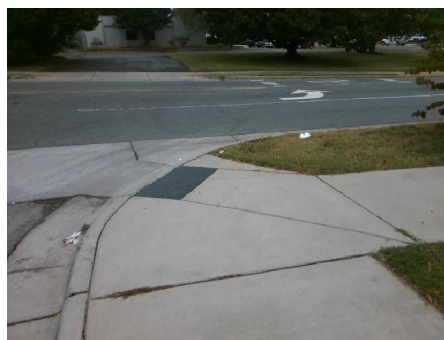
Compliance	Description	Data	Compliance	Description	Data
N/A	Ramp Length (in)	78.0	Yes	BlendTrans Slope (%)	4.9
Yes	Ramp Width (in)	48.0	No	BlendTrans XSlope (%)	5.5
N/A	Flare Type LT	N/A	N/A	Flare Type RT	N/A
N/A	Flare Slope LT (%)	N/A	N/A	Flare Slope RT (%)	N/A
N/A	Flare Traversable LT?	N/A	N/A	Flare Traversable RT?	N/A
N/A	Landing Length (in)	N/A	N/A	DWS Provided?	N/A
N/A	Landing Width (in)	N/A	N/A	DWS Contrast?	N/A
N/A	Landing Slope (%)	N/A	N/A	DWS Length (in)	N/A
N/A	Landing X Slope (%)	N/A	N/A	DWS Full Width?	N/A
N/A	Landing Curb? (Y/N)	N/A	N/A	DWS Offset (in)	N/A
N/A	Shared Landing?	N/A			
N/A	Gutter Ponding?	N/A	N/A	Gutter Slope (%)	N/A
N/A	Gutter Lip Ht (in)	N/A	N/A	Gutter X Slope (%)	N/A
N/A	Painted X Walk1?	No	N/A	Painted X Walk2?	No
	X Walk 1 Direction	To E		X Walk 2 Direction	To NW
	X Walk 1 Width (in)	N/A		X Walk 2 Width (in)	N/A
	X Walk 1 Slope (%)	3.5		X Walk 2 Slope (%)	3.4
	X Walk 1 X Slope (%)	2.6		X Walk 2 X Slope (%)	1.6

N/A	Ramp inside XWalk1?	N/A	N/A	Ramp inside XWalk2?	N/A
	Road Slope (%)	2.3		Clear Space?	N/A
	Road X Slope (%)	0.8	N/A	Clear Space to XWalk (in)	N/A
N/A	Any Obstructions?	N/A	N/A	Storm Grate/Utility Hazard?	N/A
	Obstruction Type			Storm Grate/Utility Type	
		N/A			N/A
			Yes	Surface Condition? (G/P)	Good
			No	Curb Slope (%)	12.0

Possible Solutions:

Remove & Replace Curb Ramp With Two New Directional Ramps or Equivalent.
