Access Compliance Report

Public Rights-of-Way

(Curb Ramps)

Intersection ID: 51062	Main Street: EDDLESTON_AV	Cross Street: TIPPERLINN_WY	Location: NW
ADA ID: 26626D7E0B9C	Ramp Type: PerpDiag	Initial Pass/Fail: Fail	Overall Compliance: No
Severity Score: 22.5			
Codes/Mitigation Info/Possible Solution		Field Measurements/Component Compliance

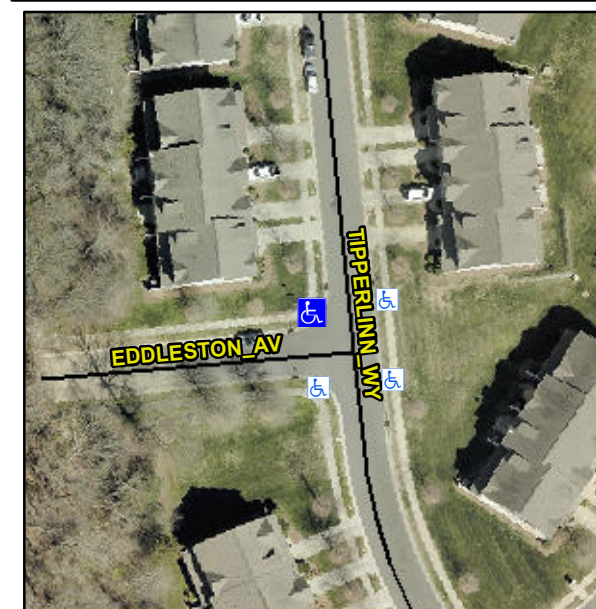
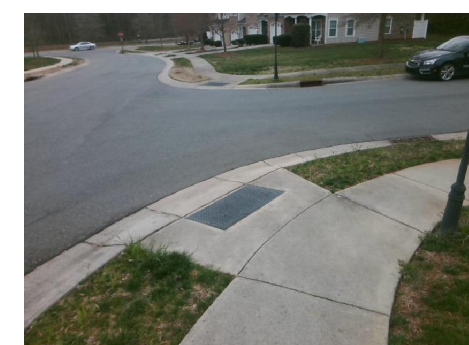
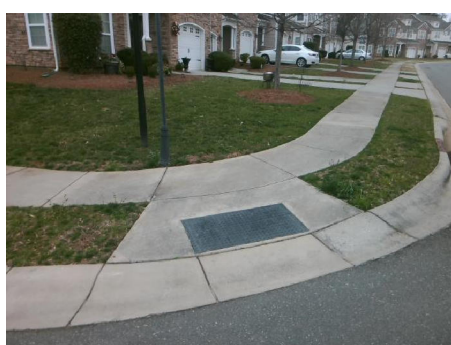
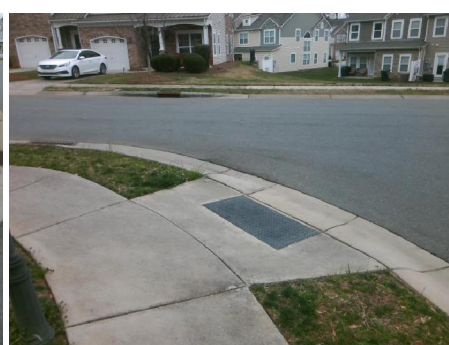
Compliance	Description	Data	Compliance	Description	Data
N/A	Ramp Length (in)	46.5	No	Ramp Slope (%)	10.1
No	Ramp Width (in)	47.5	No	Ramp XSlope (%)	4.0
N/A	Flare Type LT	N/A	N/A	Flare Type RT	N/A
N/A	Flare Slope LT (%)	N/A	N/A	Flare Slope RT (%)	N/A
N/A	Flare Traversable LT?	N/A	N/A	Flare Traversable RT?	N/A
N/A	Landing Length (in)	N/A	N/A	DWS Provided?	N/A
N/A	Landing Width (in)	N/A	N/A	DWS Contrast?	N/A
N/A	Landing Slope (%)	N/A	N/A	DWS Length (in)	N/A
N/A	Landing X Slope (%)	N/A	N/A	DWS Full Width?	N/A
N/A	Landing Curb? (Y/N)	N/A	N/A	DWS Offset (in)	N/A
N/A	Shared Landing?	N/A			
N/A	Gutter Ponding?	N/A	N/A	Gutter Slope (%)	N/A
N/A	Gutter Lip Ht (in)	N/A	N/A	Gutter X Slope (%)	N/A
N/A	Painted X Walk1?	No	N/A	Painted X Walk2?	No
	X Walk 1 Direction	To S		X Walk 2 Direction	To E
N/A	X Walk 1 Width (in)	N/A	N/A	X Walk 2 Width (in)	N/A
	X Walk 1 Slope (%)	3.1		X Walk 2 Slope (%)	1.5
	X Walk 1 X Slope (%)	3.5		X Walk 2 X Slope (%)	3.9

N/A	Ramp inside XWalk1?	N/A	N/A	Ramp inside XWalk2?	N/A
	Road Slope (%)	5.5	N/A	Clear Space?	N/A
	Road X Slope (%)	1.1	N/A	Clear Space to XWalk (in)	N/A
N/A	Any Obstructions?	N/A	N/A	Storm Grate/Utility Hazard?	N/A
	Obstruction Type			Storm Grate/Utility Type	
		N/A			N/A
			Yes	Surface Condition? (G/P)	Good

Possible Solutions:

Remove & Replace Curb Ramp With Two New Directional Ramps or Equivalent.

R304.5.1, R304.2.2, R304.5.3
