# Access Compliance Report

## Public Rights-of-Way

### (Curb Ramps)

| Intersection ID: 10036888 | Main Street: S_MCDOWELL_ST | Cross Street: N/A | Location: S |

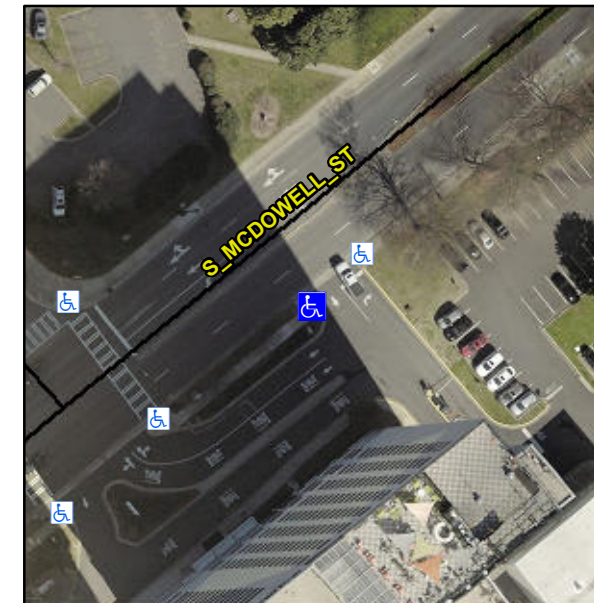
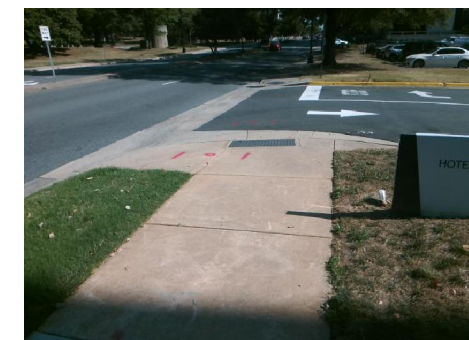
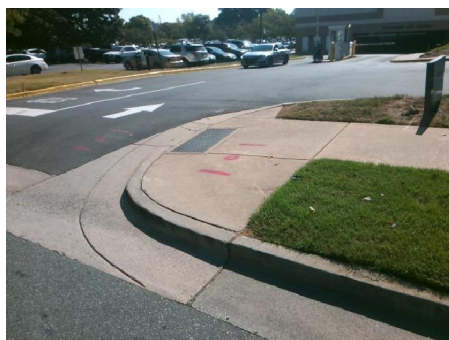
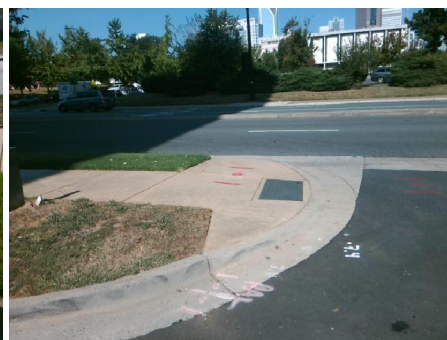
| ADA ID: 266548302F79 | Ramp Type: Directional1 | Initial Pass/Fail: Pass | Overall Compliance: No |
| | | Severity Score: 0.25 | |

**R304.5.3, R304.5.2, R305.2**

| Compliance | Description | Data | Compliance | Description | Data |
|---|---|---|---|---|---|
| No | Ramp XSlope (%) | 3.6 | | | |
| Yes | Gutter Lip Ht (in) | 0.0 | No | Gutter X Slope (%) | 3.0 |

Possible Solutions:

**Remove & Replace Entire Ramp.  
Remove & Replace Gutter.**

Total Cost: \$ 2350.00
