# Access Compliance Report

## Public Rights-of-Way

### (Curb Ramps)

| Intersection ID: 15108 | Main Street: DUNN_AV | Cross Street: HEFLIN_ST | Location: S |

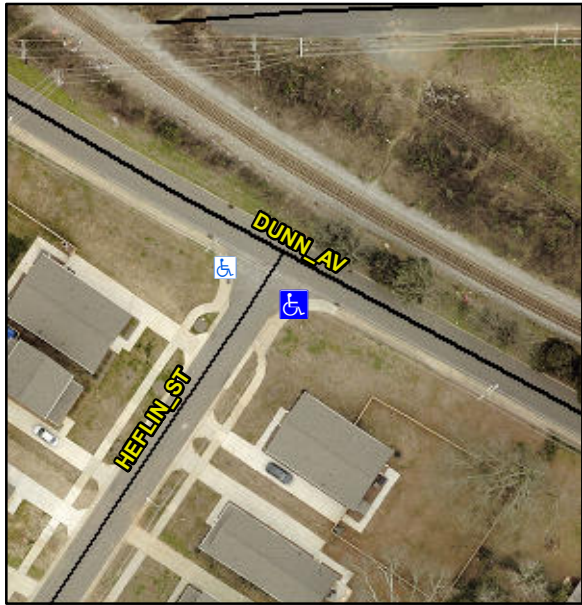
| ADA ID: 266779E20FA4 | Ramp Type: ParaDiag | Initial Pass/Fail: Fail | Overall Compliance: No |
| | | Severity Score: 8.75 | |

| Codes/Mitigation Info/Possible Solution | | | Field Measurements/Component Compliance | | | | | |
|--|---|---|---|---|---|---|---|---|
| | | | No | Ramp Width LT (in) | 45.0 | No | Ramp Width RT (in) | 47.0 |
| <b>LT RP &lt; 5%</b> | | | N/A | Gutter Ponding? | N/A | N/A | Gutter Slope (%) | N/A |
| <b>R304.5.1</b> | | | N/A | Painted X Walk1? | No | N/A | Painted X Walk2? | No |

| Codes/Mitigation Info/Possible Solution | | | Field Measurements/Component Compliance | | | | | |
|--|---|---|---|---|---|---|---|---|
| | <b>Remove &amp; Replace Curb Ramp With Two New Directional Ramps or Equivalent.</b> | | N/A | Ramp Length LT (in) | 38.0 | N/A | Ramp Length RT (in) | 38.0 |
