Access Compliance Report Public Rights-of-Way (Curb Ramps)

Intersection ID: 10019976 Main Street: ARENA_BV Cross Street: N/A Location: S

ADA ID: 266BC6F98FEB Ramp Type: PerpDiag Initial Pass/Fail: Fail Overall Compliance: No Severity Score: 33.75

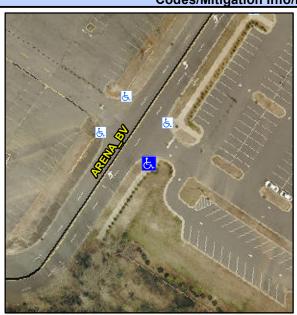
Not Found, R304.5.1, R304.2.2,
R304.5.3

Field Measurements/Component Compilance					
Compliance Description		Data	Compliance Description		Data
N/A	Ramp Length (in)	94.0	No	Ramp Slope (%)	8.5
No	Ramp Width (in)	43.0	No	Ramp XSlope (%)	5.4
N/A	Flare Type LT	N/A	N/A	Flare Type RT	N/A
N/A	Flare Slope LT (%)	N/A	N/A	Flare Slope RT (%)	N/A
N/A	Flare Traversable LT?	N/A	N/A	Flare Traversable RT?	N/A
N/A	Landing Length (in)	N/A	N/A	DWS Provided?	N/A
N/A	Landing Width (in)	N/A	N/A	DWS Contrast?	N/A
N/A	Landing Slope (%)	N/A	N/A	DWS Length (in)	N/A
N/A	Landing X Slope (%)	N/A	N/A	DWS Full Width?	N/A
N/A	Landing Curb? (Y/N)	N/A	N/A	DWS Offset (in)	N/A
N/A	Shared Landing?	N/A			
N/A	Gutter Ponding?	N/A	N/A	Gutter Slope (%)	N/A
N/A	Gutter Lip Ht (in)	N/A	N/A	Gutter X Slope (%)	N/A
N/A	Painted X Walk1?	No	N/A	Painted X Walk2?	No
	X Walk 1 Direction	To NE		X Walk 2 Direction	To NW
N/A	X Walk 1 Width (in)	N/A	N/A	X Walk 2 Width (in)	N/A
	X Walk 1 Slope (%)	4.1		X Walk 2 Slope (%)	3.5

X Walk 1 X Slope (%)	3.1		X Walk 2 X Slope (%)	5.5
N/A	Ramp inside XWalk1?	N/A	N/A	Ramp inside XWalk2?	N/A
	Road Slope (%)	6.9	N/A	Clear Space?	N/A
	Road X Slope (%)	1.2	N/A	Clear Space to XWalk (in)	N/A
N/A	Any Obstructions?	N/A	N/A	Storm Grate/Utility Hazard?	N/A
	Obstruction Type		l	Storm Grate/Utility Type	
		N/A			N/A
			Yes	Surface Condition? (G/P)	Good

Remove & Replace Curb Ramp With
Two New Directional Ramps or
Equivalent.
