Access Compliance Report

Public Rights-of-Way

(Curb Ramps)

Intersection ID: 13709	Main Street: SHENANDOAH_AV	Cross Street: ST_JULIEN_ST	Location: W
ADA ID: 26708100A250	Ramp Type: PerpDiag	Initial Pass/Fail: Fail	Overall Compliance: No
Severity Score: 8.75			
Codes/Mitigation Info/Possible Solution		Field Measurements/Component Compliance

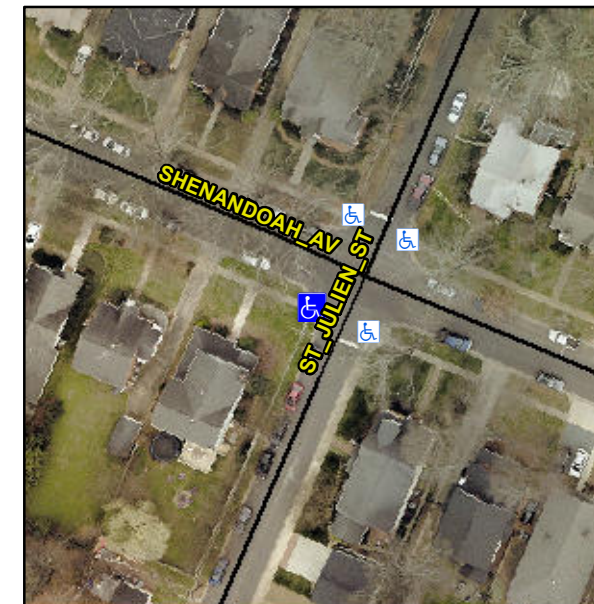
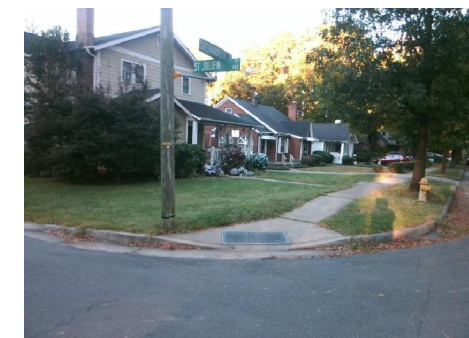
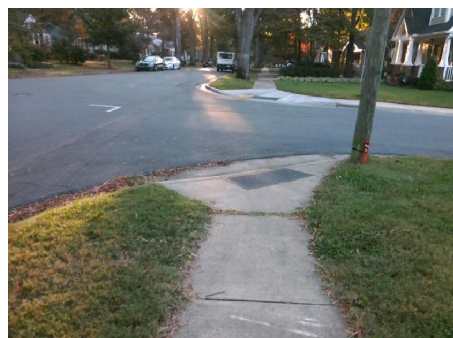
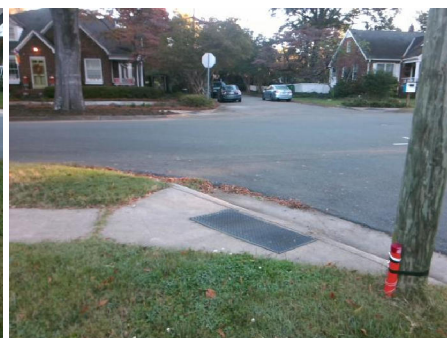
Not Found, R304.5.1

Compliance	Description	Data	Compliance	Description	Data
N/A	Ramp Length (in)	43.0	Yes	Ramp Slope (%)	7.8
No	Ramp Width (in)	47.0	Yes	Ramp XSlope (%)	1.2
N/A	Flare Type LT	N/A	N/A	Flare Type RT	N/A
N/A	Flare Slope LT (%)	N/A	N/A	Flare Slope RT (%)	N/A
N/A	Flare Traversable LT?	N/A	N/A	Flare Traversable RT?	N/A
N/A	Landing Length (in)	N/A	N/A	DWS Provided?	N/A
N/A	Landing Width (in)	N/A	N/A	DWS Contrast?	N/A
N/A	Landing Slope (%)	N/A	N/A	DWS Length (in)	N/A
N/A	Landing X Slope (%)	N/A	N/A	DWS Full Width?	N/A
N/A	Landing Curb? (Y/N)	N/A	N/A	DWS Offset (in)	N/A
N/A	Shared Landing?	N/A			
N/A	Gutter Ponding?	N/A	N/A	Gutter Slope (%)	N/A
N/A	Gutter Lip Ht (in)	1.5	N/A	Gutter X Slope (%)	N/A
N/A	Painted X Walk1?	No	N/A	Painted X Walk2?	No
	X Walk 1 Direction	To SE		X Walk 2 Direction	To NE
N/A	X Walk 1 Width (in)	N/A	N/A	X Walk 2 Width (in)	N/A
	X Walk 1 Slope (%)	8.7		X Walk 2 Slope (%)	5.2
	X Walk 1 X Slope (%)	4.4		X Walk 2 X Slope (%)	2.8

N/A	Ramp inside XWalk1?	N/A	N/A	Ramp inside XWalk2?	N/A
	Road Slope (%)	4.6	N/A	Clear Space?	N/A
	Road X Slope (%)	9.1	N/A	Clear Space to XWalk (in)	N/A
N/A	Any Obstructions?	N/A	N/A	Storm Grate/Utility Hazard?	N/A
	Obstruction Type			Storm Grate/Utility Type	
		N/A			N/A
		Yes		Surface Condition? (G/P)	Good

Remove & Replace Curb Ramp With Two New Directional Ramps or Equivalent.

Total Cost: \$ 3200.00
