Access Compliance Report

Public Rights-of-Way

(Curb Ramps)

Intersection ID: 19698	Main Street: PARK_RD	Cross Street: SCOFIELD_RD	Location: NE
ADA ID: 267223D56D5B	Ramp Type: PerpDiag	Initial Pass/Fail: Fail	Overall Compliance: No
		Severity Score: 10

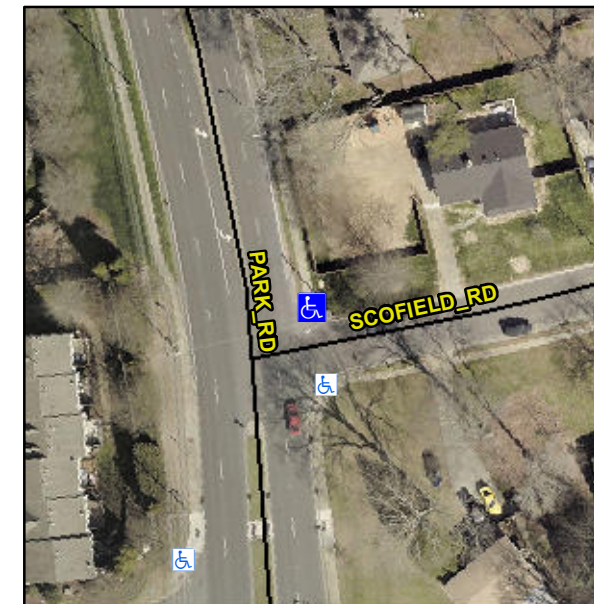
Compliance	Description	Data	Compliance	Description	Data
N/A	Ramp Length (in)	61.0	Yes	Ramp Slope (%)	5.8
No	Ramp Width (in)	46.5	No	Ramp XSlope (%)	2.3
N/A	Flare Type LT	N/A	N/A	Flare Type RT	N/A
N/A	Flare Slope LT (%)	N/A	N/A	Flare Slope RT (%)	N/A
N/A	Flare Traversable LT?	N/A	N/A	Flare Traversable RT?	N/A
N/A	Landing Length (in)	N/A	N/A	DWS Provided?	N/A
N/A	Landing Width (in)	N/A	N/A	DWS Contrast?	N/A
N/A	Landing Slope (%)	N/A	N/A	DWS Length (in)	N/A
N/A	Landing X Slope (%)	N/A	N/A	DWS Full Width?	N/A
N/A	Landing Curb? (Y/N)	N/A	N/A	DWS Offset (in)	N/A
N/A	Shared Landing?	N/A			
N/A	Gutter Ponding?	N/A	N/A	Gutter Slope (%)	N/A
N/A	Gutter Lip Ht (in)	N/A	N/A	Gutter X Slope (%)	N/A
N/A	Painted X Walk1?	No	N/A	Painted X Walk2?	No
	X Walk 1 Direction	To W		X Walk 2 Direction	To S
N/A	X Walk 1 Width (in)	N/A	N/A	X Walk 2 Width (in)	N/A
	X Walk 1 Slope (%)	2.2		X Walk 2 Slope (%)	2.1
	X Walk 1 X Slope (%)	2.4		X Walk 2 X Slope (%)	1.0

N/A	Ramp inside XWalk1?	N/A	N/A	Ramp inside XWalk2?	N/A
	Road Slope (%)	1.2	N/A	Clear Space?	N/A
	Road X Slope (%)	6.8	N/A	Clear Space to XWalk (in)	N/A
N/A	Any Obstructions?	N/A	N/A	Storm Grate/Utility Hazard?	N/A
	Obstruction Type			Storm Grate/Utility Type	
		N/A			N/A
			Yes	Surface Condition? (G/P)	Good

Remove & Replace Curb Ramp With Two New Directional Ramps or Equivalent.

R304.5.1, R304.5.3
