# Access Compliance Report

## Public Rights-of-Way

### (Curb Ramps)

| Intersection ID: 6492 | Main Street: OASIS_LN | Cross Street: BELMEADE_GREEN_DR | Location: SE |

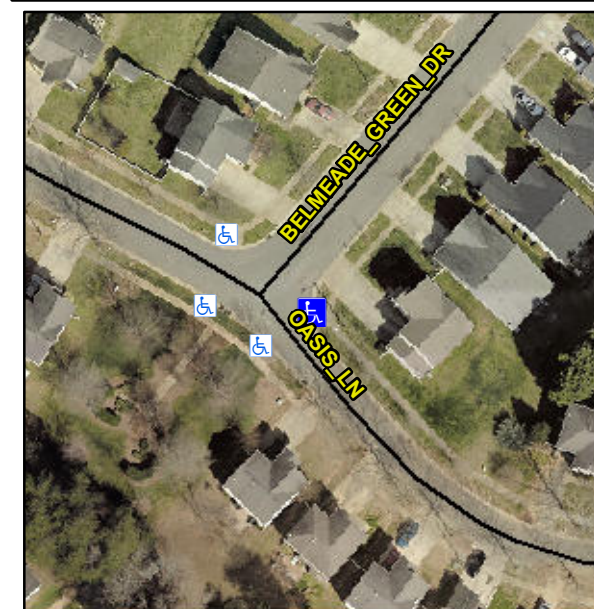
| ADA ID: 26746E7CE0EF | Ramp Type: PerpDiag | Initial Pass/Fail: Fail | Overall Compliance: No |
| Severity Score: 12.5 | | | |

**R304.5.3**

| Compliance | Description | Data | Compliance | Description | Data |
|---|---|---|---|---|---|
| N/A | Ramp Length (in) | 83.0 | Yes | Ramp Slope (%) | 8.1 |
| Yes | Ramp Width (in) | 50.0 | No | Ramp XSlope (%) | 6.3 |

**Remove & Replace Curb Ramp With Two New Directional Ramps or Equivalent.**

**\$ 3200.00**
