Access Compliance Report

Public Rights-of-Way

(Curb Ramps)

| Intersection ID: 21919 | Main Street: NATIONS_FORD_RD | Cross Street: OLD_HEBRON_RD | Location: SE |

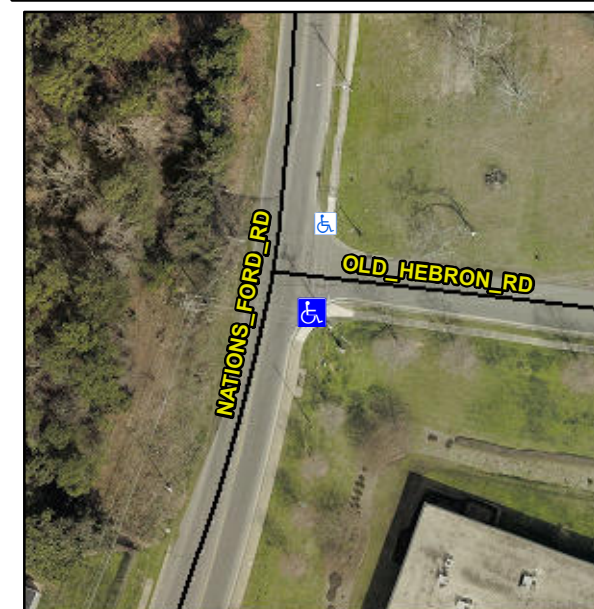
| ADA ID: 26760B24F54F | Ramp Type: ParaDiag | Initial Pass/Fail: Fail | Overall Compliance: No |
| Severity Score: 12.5 | | | |

R304.3.2

| Compliance | Description | Data | Compliance | Description | Data |
|---|---|---|---|---|---|
| No | Ramp Slope LT (%) | 10.6 | Yes | Ramp Slope RT (%) | 7.2 |

Remove & Replace Curb Ramp With Two New Directional Ramps or Equivalent.
