# Access Compliance Report

## Public Rights-of-Way

### (Curb Ramps)

Intersection ID: 9004	Main Street: BOYD_ST	Cross Street: MARIETTA_ST	Location: S
ADA ID: 2683AD5E162E	Ramp Type: Perp	Initial Pass/Fail: Fail	Overall Compliance: No
Severity Score: 18.75			
Codes/Mitigation Info/Possible Solution		Field Measurements/Component Compliance

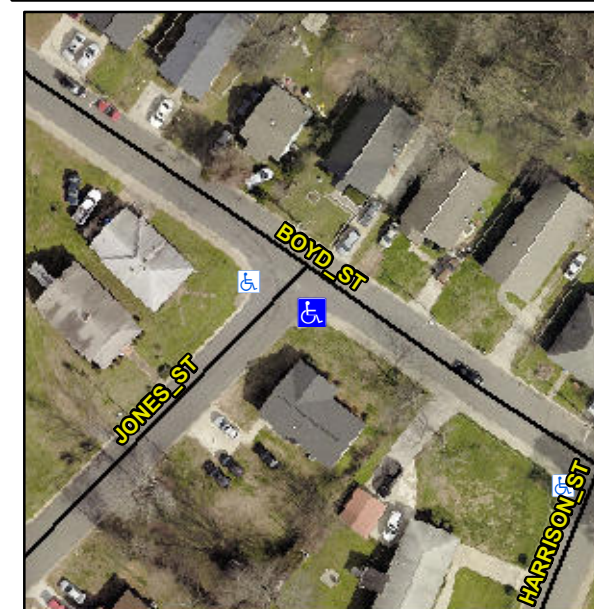
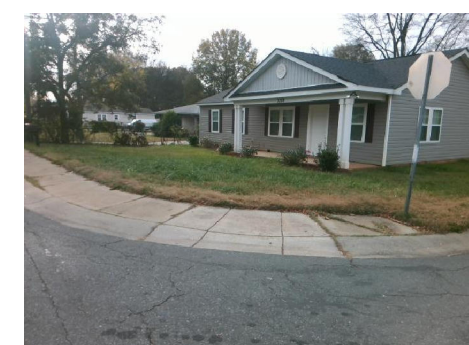
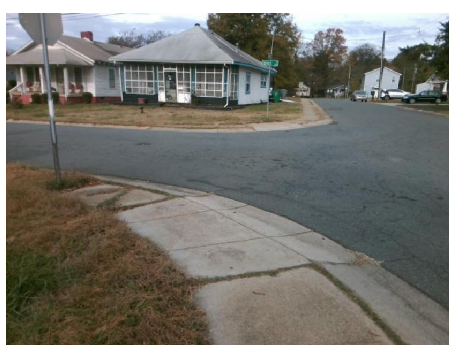
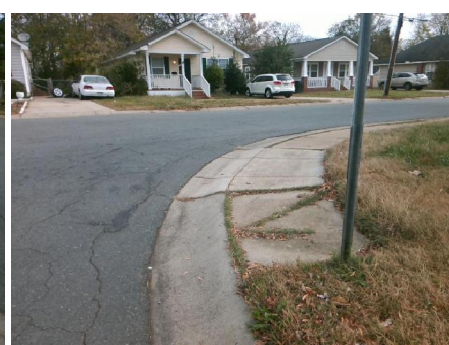
**Not Found, R304.5.1, R304.5.3**

Compliance	Description	Data	Compliance	Description	Data
N/A	Ramp Length (in)	50.0	Yes	Ramp Slope (%)	5.4
No	Ramp Width (in)	35.5	No	Ramp XSlope (%)	3.1
N/A	Flare Type LT	N/A	N/A	Flare Type RT	N/A
N/A	Flare Slope LT (%)	N/A	N/A	Flare Slope RT (%)	N/A
N/A	Flare Traversable LT?	N/A	N/A	Flare Traversable RT?	N/A
N/A	Landing Length (in)	N/A	N/A	DWS Provided?	N/A
N/A	Landing Width (in)	N/A	N/A	DWS Contrast?	N/A
N/A	Landing Slope (%)	N/A	N/A	DWS Length (in)	N/A
N/A	Landing X Slope (%)	N/A	N/A	DWS Full Width?	N/A
N/A	Landing Curb? (Y/N)	N/A	N/A	DWS Offset (in)	N/A
N/A	Shared Landing?	N/A			
N/A	Gutter Ponding?	N/A	N/A	Gutter Slope (%)	N/A
N/A	Gutter Lip Ht (in)	0.5	N/A	Gutter X Slope (%)	N/A
N/A	Painted X Walk1?	No	N/A	Painted X Walk2?	N/A
	X Walk 1 Direction	To NW		X Walk 2 Direction	N/A
N/A	X Walk 1 Width (in)	N/A	N/A	X Walk 2 Width (in)	N/A
	X Walk 1 Slope (%)	1.0		X Walk 2 Slope (%)	N/A
	X Walk 1 X Slope (%)	3.7		X Walk 2 X Slope (%)	N/A

N/A	Ramp inside XWalk1?	N/A	N/A	Ramp inside XWalk2?	N/A
	Road Slope (%)	N/A	N/A	Clear Space?	N/A
	Road X Slope (%)	N/A	N/A	Clear Space to XWalk (in)	N/A
N/A	Any Obstructions?	N/A	N/A	Storm Grate/Utility Hazard?	N/A
	Obstruction Type			Storm Grate/Utility Type	
		N/A			N/A
		Yes		Surface Condition? (G/P)	Good

**Remove & Replace Entire Ramp.**
