Access Compliance Report

Public Rights-of-Way

(Curb Ramps)

Intersection ID: 11867	Main Street: E_17TH_ST	Cross Street: SEIGLE_AV	Location: SE
ADA ID: 2683C9C1D097	Ramp Type: Perp	Initial Pass/Fail: Fail	Overall Compliance: No
Severity Score: 21.25			
Codes/Mitigation Info/Possible Solution		Field Measurements/Component Compliance

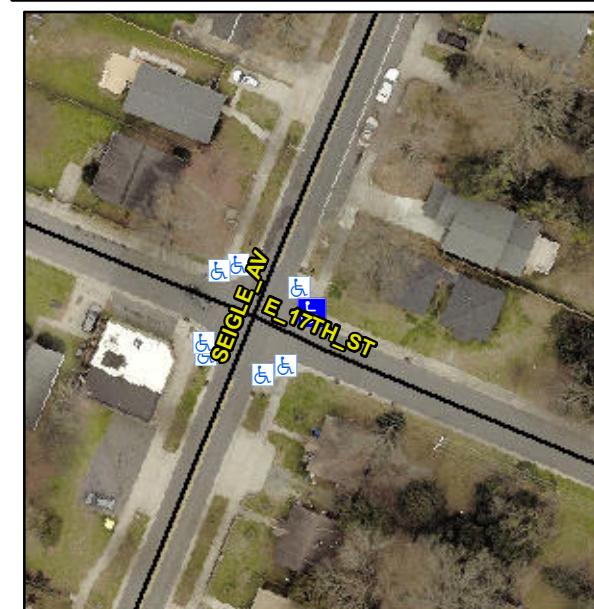
Not Found, R304.5.1, R304.2.2

Compliance	Description	Data	Compliance	Description	Data
N/A	Ramp Length (in)	48.0	No	Ramp Slope (%)	9.0
No	Ramp Width (in)	47.0	Yes	Ramp XSlope (%)	0.6
N/A	Flare Type LT	N/A	N/A	Flare Type RT	N/A
N/A	Flare Slope LT (%)	N/A	N/A	Flare Slope RT (%)	N/A
N/A	Flare Traversable LT?	N/A	N/A	Flare Traversable RT?	N/A
N/A	Landing Length (in)	N/A	N/A	DWS Provided?	N/A
N/A	Landing Width (in)	N/A	N/A	DWS Contrast?	N/A
N/A	Landing Slope (%)	N/A	N/A	DWS Length (in)	N/A
N/A	Landing X Slope (%)	N/A	N/A	DWS Full Width?	N/A
N/A	Landing Curb? (Y/N)	N/A	N/A	DWS Offset (in)	N/A
N/A	Shared Landing?	N/A			
N/A	Gutter Ponding?	N/A	N/A	Gutter Slope (%)	N/A
N/A	Gutter Lip Ht (in)	N/A	N/A	Gutter X Slope (%)	N/A
N/A	Painted X Walk1?	No	N/A	Painted X Walk2?	N/A
	X Walk 1 Direction	To SW		X Walk 2 Direction	N/A
N/A	X Walk 1 Width (in)	N/A	N/A	X Walk 2 Width (in)	N/A
	X Walk 1 Slope (%)	5.9		X Walk 2 Slope (%)	N/A
	X Walk 1 X Slope (%)	1.2		X Walk 2 X Slope (%)	N/A

N/A	Ramp inside XWalk1?	N/A	N/A	Ramp inside XWalk2?	N/A
	Road Slope (%)	N/A	N/A	Clear Space?	N/A
	Road X Slope (%)	N/A	N/A	Clear Space to XWalk (in)	N/A
N/A	Any Obstructions?	N/A	N/A	Storm Grate/Utility Hazard?	N/A
	Obstruction Type			Storm Grate/Utility Type	
		N/A			N/A
			Yes	Surface Condition? (G/P)	Good

Remove & Replace Entire Ramp.

Total Cost: \$ 1850.00
