# Access Compliance Report

## Public Rights-of-Way

### (Curb Ramps)

Intersection ID: 4524	Main Street: CLAIREMORE_PL	Cross Street: FELDBANK_DR	Location: SW
ADA ID: 2688F9A93F06	Ramp Type: BlendTrans1	Initial Pass/Fail: Fail	Overall Compliance: No
		Severity Score: 10

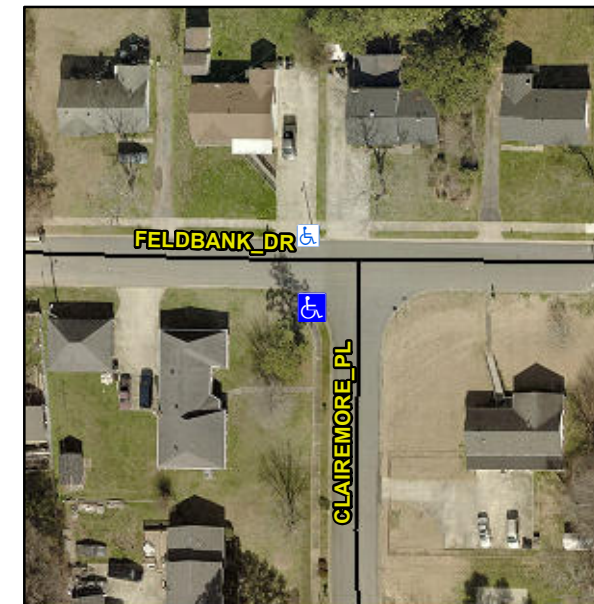
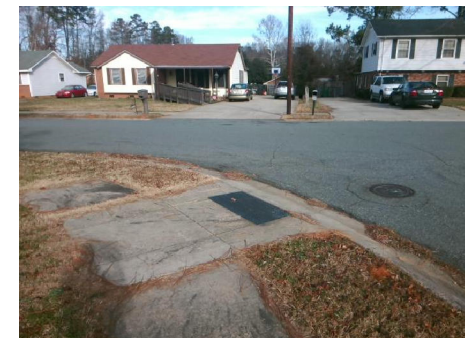
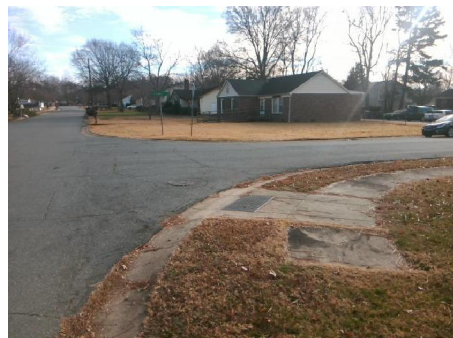
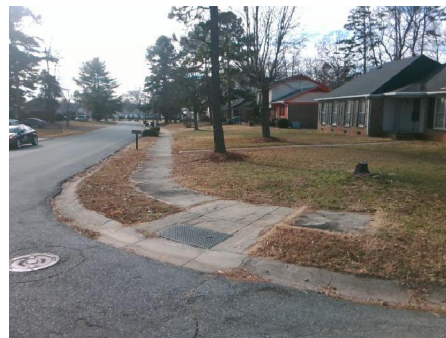
**Not Found, R304.5.1**

Compliance	Description	Data	Compliance	Description	Data
N/A	Ramp Length (in)	49.0	Yes	BlendTrans Slope (%)	3.6
No	Ramp Width (in)	42.5	Yes	BlendTrans XSlope (%)	2.5
N/A	Flare Type LT	N/A	N/A	Flare Type RT	N/A
N/A	Flare Slope LT (%)	N/A	N/A	Flare Slope RT (%)	N/A
N/A	Flare Traversable LT?	N/A	N/A	Flare Traversable RT?	N/A
N/A	Landing Length (in)	N/A	N/A	DWS Provided?	N/A
N/A	Landing Width (in)	N/A	N/A	DWS Contrast?	N/A
N/A	Landing Slope (%)	N/A	N/A	DWS Length (in)	N/A
N/A	Landing X Slope (%)	N/A	N/A	DWS Full Width?	N/A
N/A	Landing Curb? (Y/N)	N/A	N/A	DWS Offset (in)	N/A
N/A	Shared Landing?	N/A			
N/A	Gutter Ponding?	N/A	N/A	Gutter Slope (%)	N/A
N/A	Gutter Lip Ht (in)	1.0	N/A	Gutter X Slope (%)	N/A
N/A	Painted X Walk1?	No	N/A	Painted X Walk2?	N/A
	X Walk 1 Direction	To N		X Walk 2 Direction	N/A
	X Walk 1 Width (in)	N/A		X Walk 2 Width (in)	N/A
	X Walk 1 Slope (%)	6.9		X Walk 2 Slope (%)	N/A
	X Walk 1 X Slope (%)	2.8		X Walk 2 X Slope (%)	N/A

N/A	Ramp inside XWalk1?	N/A	N/A	Ramp inside XWalk2?	N/A
	Road Slope (%)	2.8		Clear Space?	N/A
	Road X Slope (%)	6.9	N/A	Clear Space to XWalk (in)	N/A
N/A	Any Obstructions?	N/A	N/A	Storm Grate/Utility Hazard?	N/A
	Obstruction Type			Storm Grate/Utility Type	
		N/A			N/A
			Yes	Surface Condition? (G/P)	Good
			No	Curb Slope (%)	8.0

**Remove & Replace Curb Ramp With Two New Directional Ramps or Equivalent.**
