Access Compliance Report

Public Rights-of-Way

(Curb Ramps)

Intersection ID: 14941	Main Street: BENJAMIN_ST	Cross Street: S_TRYON_ST	Location:	N
ADA ID: 268A9836EBC6	Ramp Type: PerpDiag	Initial Pass/Fail: Fail	Overall Compliance: No	Severity Score: 12.5

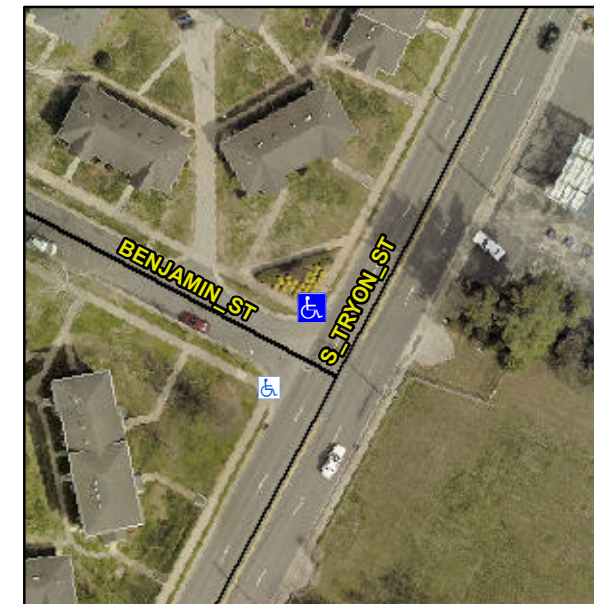
Not Found, R304.2.2

Compliance	Description	Data	Compliance	Description	Data
N/A	Ramp Length (in)	60.0	No	Ramp Slope (%)	10.0
Yes	Ramp Width (in)	48.0	Yes	Ramp XSlope (%)	0.3
N/A	Flare Type LT	N/A	N/A	Flare Type RT	N/A
N/A	Flare Slope LT (%)	N/A	N/A	Flare Slope RT (%)	N/A
N/A	Flare Traversable LT?	N/A	N/A	Flare Traversable RT?	N/A
N/A	Landing Length (in)	N/A	N/A	DWS Provided?	N/A
N/A	Landing Width (in)	N/A	N/A	DWS Contrast?	N/A
N/A	Landing Slope (%)	N/A	N/A	DWS Length (in)	N/A
N/A	Landing X Slope (%)	N/A	N/A	DWS Full Width?	N/A
N/A	Landing Curb? (Y/N)	N/A	N/A	DWS Offset (in)	N/A
N/A	Shared Landing?	N/A			
N/A	Gutter Ponding?	N/A	N/A	Gutter Slope (%)	N/A
N/A	Gutter Lip Ht (in)	N/A	N/A	Gutter X Slope (%)	N/A
N/A	Painted X Walk1?	No	N/A	Painted X Walk2?	No
	X Walk 1 Direction	To SW		X Walk 2 Direction	To SE
N/A	X Walk 1 Width (in)	N/A	N/A	X Walk 2 Width (in)	N/A
	X Walk 1 Slope (%)	2.6		X Walk 2 Slope (%)	1.6
	X Walk 1 X Slope (%)	1.9		X Walk 2 X Slope (%)	3.4

N/A	Ramp inside XWalk1?	N/A	N/A	Ramp inside XWalk2?	N/A
	Road Slope (%)	0.9	N/A	Clear Space?	N/A
	Road X Slope (%)	0.5	N/A	Clear Space to XWalk (in)	N/A
N/A	Any Obstructions?	N/A	N/A	Storm Grate/Utility Hazard?	N/A
	Obstruction Type			Storm Grate/Utility Type	
		N/A			N/A
			Yes	Surface Condition? (G/P)	Good

Possible Solutions:

Remove & Replace Curb Ramp With Two New Directional Ramps or Equivalent.
