Access Compliance Report

Public Rights-of-Way

(Curb Ramps)

Intersection ID: 29270	Main Street: CHALK_HILL_LN	Cross Street: SPARROW_VALLEY_WY	Location: NW
ADA ID: 269BE8424EDC	Ramp Type: BlendTrans1	Initial Pass/Fail: Fail	Overall Compliance: No
			Severity Score: 21.25

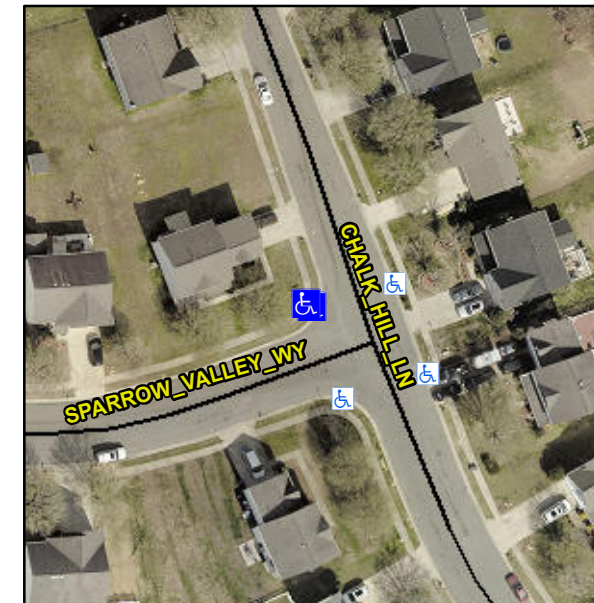
Not Found, R304.5.1, R304.5.3

Compliance	Description	Data	Compliance	Description	Data
N/A	Ramp Length (in)	52.0	Yes	BlendTrans Slope (%)	2.3
No	Ramp Width (in)	47.5	No	BlendTrans XSlope (%)	5.1
N/A	Flare Type LT	N/A	N/A	Flare Type RT	N/A
N/A	Flare Slope LT (%)	N/A	N/A	Flare Slope RT (%)	N/A
N/A	Flare Traversable LT?	N/A	N/A	Flare Traversable RT?	N/A
N/A	Landing Length (in)	N/A	N/A	DWS Provided?	N/A
N/A	Landing Width (in)	N/A	N/A	DWS Contrast?	N/A
N/A	Landing Slope (%)	N/A	N/A	DWS Length (in)	N/A
N/A	Landing X Slope (%)	N/A	N/A	DWS Full Width?	N/A
N/A	Landing Curb? (Y/N)	N/A	N/A	DWS Offset (in)	N/A
N/A	Shared Landing?	N/A			
N/A	Gutter Ponding?	N/A	N/A	Gutter Slope (%)	N/A
N/A	Gutter Lip Ht (in)	N/A	N/A	Gutter X Slope (%)	N/A
N/A	Painted X Walk1?	No	N/A	Painted X Walk2?	No
	X Walk 1 Direction	To SE		X Walk 2 Direction	To NE
	X Walk 1 Width (in)	N/A		X Walk 2 Width (in)	N/A
	X Walk 1 Slope (%)	0.8		X Walk 2 Slope (%)	2.5
	X Walk 1 X Slope (%)	5.8		X Walk 2 X Slope (%)	0.5

N/A	Ramp inside XWalk1?	N/A	N/A	Ramp inside XWalk2?	N/A
	Road Slope (%)	4.2		Clear Space?	N/A
	Road X Slope (%)	4.0	N/A	Clear Space to XWalk (in)	N/A
N/A	Any Obstructions?	N/A	N/A	Storm Grate/Utility Hazard?	N/A
	Obstruction Type			Storm Grate/Utility Type	
		N/A			N/A
			Yes	Surface Condition? (G/P)	Good
			No	Curb Slope (%)	6.4

Possible Solutions:

Remove & Replace Curb Ramp With Two New Directional Ramps or Equivalent.
