Access Compliance Report

Public Rights-of-Way

(Curb Ramps)

Intersection ID: 13147	Main Street: GORDON_ST	Cross Street: PECAN_AV	Location: SE
ADA ID: 269D628BB9F5	Ramp Type: Perp	Initial Pass/Fail: Fail	Overall Compliance: No
		Severity Score: 25

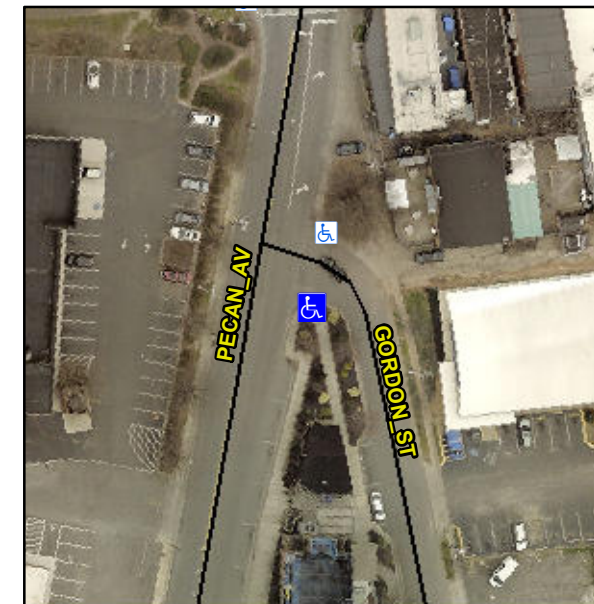
Compliance	Description	Data	Compliance	Description	Data
N/A	Ramp Length (in)	65.0	No	Ramp Slope (%)	8.5
Yes	Ramp Width (in)	48.0	No	Ramp XSlope (%)	5.8
N/A	Flare Type LT	N/A	N/A	Flare Type RT	N/A
N/A	Flare Slope LT (%)	N/A	N/A	Flare Slope RT (%)	N/A
N/A	Flare Traversable LT?	N/A	N/A	Flare Traversable RT?	N/A
N/A	Landing Length (in)	N/A	N/A	DWS Provided?	N/A
N/A	Landing Width (in)	N/A	N/A	DWS Contrast?	N/A
N/A	Landing Slope (%)	N/A	N/A	DWS Length (in)	N/A
N/A	Landing X Slope (%)	N/A	N/A	DWS Full Width?	N/A
N/A	Landing Curb? (Y/N)	N/A	N/A	DWS Offset (in)	N/A
N/A	Shared Landing?	N/A			
N/A	Gutter Ponding?	N/A	N/A	Gutter Slope (%)	N/A
N/A	Gutter Lip Ht (in)	N/A	N/A	Gutter X Slope (%)	N/A
N/A	Painted X Walk1?	No	N/A	Painted X Walk2?	N/A
	X Walk 1 Direction	To N		X Walk 2 Direction	N/A
N/A	X Walk 1 Width (in)	N/A	N/A	X Walk 2 Width (in)	N/A
	X Walk 1 Slope (%)	0.2		X Walk 2 Slope (%)	N/A
	X Walk 1 X Slope (%)	7.4		X Walk 2 X Slope (%)	N/A

N/A	Ramp inside XWalk1?	N/A	N/A	Ramp inside XWalk2?	N/A
	Road Slope (%)	N/A	N/A	Clear Space?	N/A
	Road X Slope (%)	N/A	N/A	Clear Space to XWalk (in)	N/A
N/A	Any Obstructions?	N/A	N/A	Storm Grate/Utility Hazard?	N/A
	Obstruction Type			Storm Grate/Utility Type	
		N/A			N/A
			Yes	Surface Condition? (G/P)	Good

Possible Solutions:

Remove & Replace Entire Ramp.

R304.2.2, R304.5.3
