# Access Compliance Report

## Public Rights-of-Way

### (Curb Ramps)

Intersection ID: 21804	Main Street: NOLLEY_CT	Cross Street: GALLERIA_BV	Location: NE
ADA ID: 26B915878488	Ramp Type: Perp	Initial Pass/Fail: Fail	Overall Compliance: No
		Severity Score: 8.75

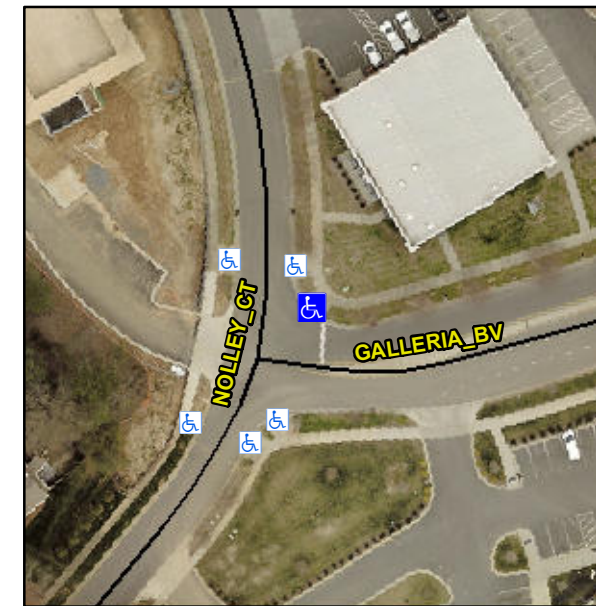
Compliance	Description	Data	Compliance	Description	Data
N/A	Ramp Length (in)	98.0	Yes	Ramp Slope (%)	6.1
No	Ramp Width (in)	47.0	Yes	Ramp XSlope (%)	0.3
N/A	Flare Type LT	N/A	N/A	Flare Type RT	N/A
N/A	Flare Slope LT (%)	N/A	N/A	Flare Slope RT (%)	N/A
N/A	Flare Traversable LT?	N/A	N/A	Flare Traversable RT?	N/A
N/A	Landing Length (in)	N/A	N/A	DWS Provided?	N/A
N/A	Landing Width (in)	N/A	N/A	DWS Contrast?	N/A
N/A	Landing Slope (%)	N/A	N/A	DWS Length (in)	N/A
N/A	Landing X Slope (%)	N/A	N/A	DWS Full Width?	N/A
N/A	Landing Curb? (Y/N)	N/A	N/A	DWS Offset (in)	N/A
N/A	Shared Landing?	N/A			
N/A	Gutter Ponding?	N/A	N/A	Gutter Slope (%)	N/A
N/A	Gutter Lip Ht (in)	N/A	N/A	Gutter X Slope (%)	N/A
N/A	Painted X Walk1?	No	N/A	Painted X Walk2?	N/A
	X Walk 1 Direction	To SW		X Walk 2 Direction	N/A
N/A	X Walk 1 Width (in)	N/A	N/A	X Walk 2 Width (in)	N/A
	X Walk 1 Slope (%)	2.8		X Walk 2 Slope (%)	N/A
	X Walk 1 X Slope (%)	0.9		X Walk 2 X Slope (%)	N/A

N/A	Ramp inside XWalk1?	N/A	N/A	Ramp inside XWalk2?	N/A
	Road Slope (%)	N/A	N/A	Clear Space?	N/A
	Road X Slope (%)	N/A	N/A	Clear Space to XWalk (in)	N/A
N/A	Any Obstructions?	N/A	N/A	Storm Grate/Utility Hazard?	N/A
	Obstruction Type			Storm Grate/Utility Type	
		N/A			N/A
			Yes	Surface Condition? (G/P)	Good

Possible Solutions:

**Remove & Replace Entire Ramp.**

**R304.5.1**
