Access Compliance Report

Public Rights-of-Way

(Curb Ramps)

Intersection ID: 46698	Main Street: COFFEEBERRY_LN	Cross Street: TROTTERS_RIDGE_RD	Location: SW
ADA ID: 26BEAA7948D0	Ramp Type: PerpDiag	Initial Pass/Fail: Fail	Overall Compliance: No
Severity Score: 22.5			
Codes/Mitigation Info/Possible Solution		Field Measurements/Component Compliance

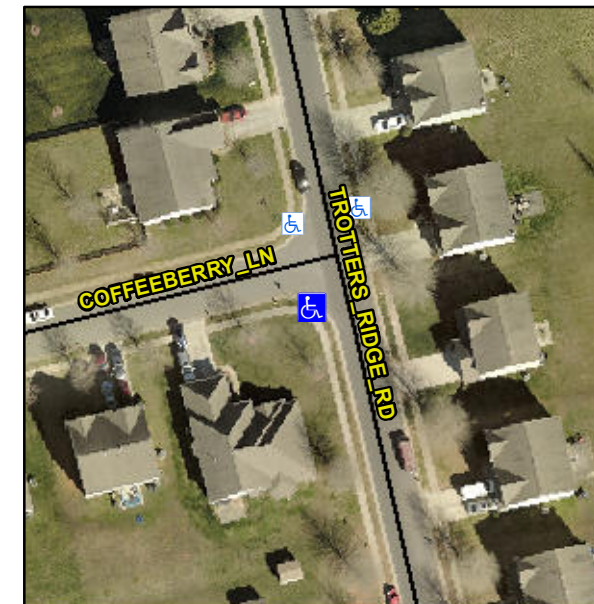
Not Found, R304.5.1, R304.2.2, R304.5.3

Compliance	Description	Data	Compliance	Description	Data
N/A	Ramp Length (in)	49.0	No	Ramp Slope (%)	8.7
No	Ramp Width (in)	46.0	No	Ramp XSlope (%)	2.6
N/A	Flare Type LT	N/A	N/A	Flare Type RT	N/A
N/A	Flare Slope LT (%)	N/A	N/A	Flare Slope RT (%)	N/A
N/A	Flare Traversable LT?	N/A	N/A	Flare Traversable RT?	N/A
N/A	Landing Length (in)	N/A	N/A	DWS Provided?	N/A
N/A	Landing Width (in)	N/A	N/A	DWS Contrast?	N/A
N/A	Landing Slope (%)	N/A	N/A	DWS Length (in)	N/A
N/A	Landing X Slope (%)	N/A	N/A	DWS Full Width?	N/A
N/A	Landing Curb? (Y/N)	N/A	N/A	DWS Offset (in)	N/A
N/A	Shared Landing?	N/A			
N/A	Gutter Ponding?	N/A	N/A	Gutter Slope (%)	N/A
N/A	Gutter Lip Ht (in)	N/A	N/A	Gutter X Slope (%)	N/A
N/A	Painted X Walk1?	No	N/A	Painted X Walk2?	No
	X Walk 1 Direction	To E		X Walk 2 Direction	To N
N/A	X Walk 1 Width (in)	N/A	N/A	X Walk 2 Width (in)	N/A
	X Walk 1 Slope (%)	3.3		X Walk 2 Slope (%)	1.1
	X Walk 1 X Slope (%)	2.0		X Walk 2 X Slope (%)	3.1

N/A	Ramp inside XWalk1?	N/A	N/A	Ramp inside XWalk2?	N/A
	Road Slope (%)	3.5	N/A	Clear Space?	N/A
	Road X Slope (%)	2.3	N/A	Clear Space to XWalk (in)	N/A
N/A	Any Obstructions?	N/A	N/A	Storm Grate/Utility Hazard?	N/A
	Obstruction Type			Storm Grate/Utility Type	
		N/A			N/A
			Yes	Surface Condition? (G/P)	Good

Remove & Replace Curb Ramp With Two New Directional Ramps or Equivalent.
