# Access Compliance Report

## Public Rights-of-Way

### (Curb Ramps)

| Intersection ID: 10034377 | Main Street: CAMERON_VALLEY_PY | Cross Street: PHILLIPS_PL | Location: NW |

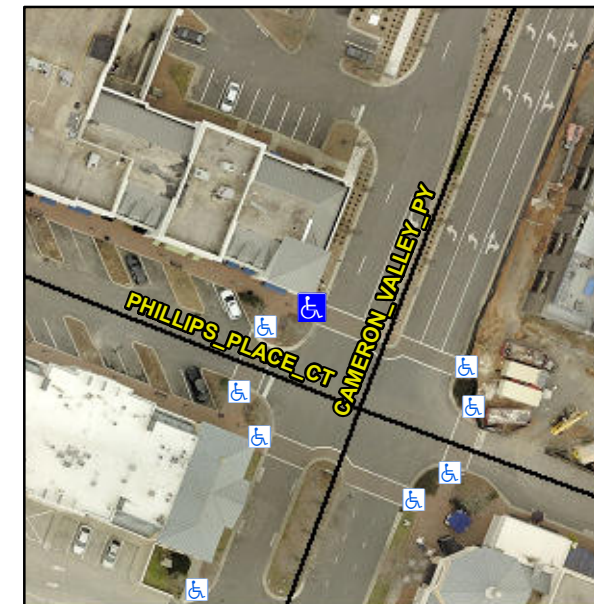
**XWALK PAVERS**

**R304.5.3**

| Compliance | Description | Data | Compliance | Description | Data |
|---|---|---|---|---|---|
| Yes | Ramp Width (in) | 123.5 | No | BlendTrans XSlope (%) | 5.1 |

**Remove & Replace Curb Ramp With Two New Directional Ramps or Equivalent.**
