Access Compliance Report

Public Rights-of-Way

(Curb Ramps)

Intersection ID: 16707	Main Street: BEVERLY_DR	Cross Street: HAMPTON_AV	Location: SW
ADA ID: 26CD5B13C573	Ramp Type: PerpDiag	Initial Pass/Fail: Fail	Overall Compliance: No
Severity Score: 33.75			
Codes/Mitigation Info/Possible Solution		Field Measurements/Component Compliance

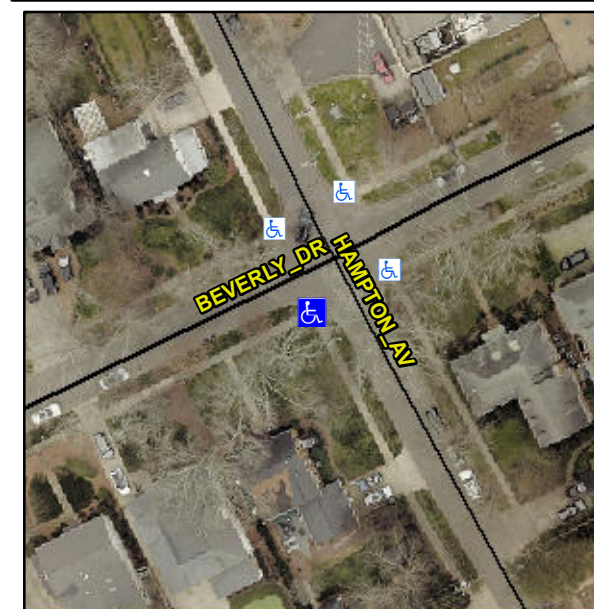
Compliance	Description	Data	Compliance	Description	Data
N/A	Ramp Length (in)	54.0	No	Ramp Slope (%)	12.7
No	Ramp Width (in)	42.0	Yes	Ramp XSlope (%)	1.2
N/A	Flare Type LT	N/A	N/A	Flare Type RT	N/A
N/A	Flare Slope LT (%)	N/A	N/A	Flare Slope RT (%)	N/A
N/A	Flare Traversable LT?	N/A	N/A	Flare Traversable RT?	N/A
N/A	Landing Length (in)	N/A	N/A	DWS Provided?	N/A
N/A	Landing Width (in)	N/A	N/A	DWS Contrast?	N/A
N/A	Landing Slope (%)	N/A	N/A	DWS Length (in)	N/A
N/A	Landing X Slope (%)	N/A	N/A	DWS Full Width?	N/A
N/A	Landing Curb? (Y/N)	N/A	N/A	DWS Offset (in)	N/A
N/A	Shared Landing?	N/A			
N/A	Gutter Ponding?	N/A	N/A	Gutter Slope (%)	N/A
N/A	Gutter Lip Ht (in)	N/A	N/A	Gutter X Slope (%)	N/A
N/A	Painted X Walk1?	No	N/A	Painted X Walk2?	No
	X Walk 1 Direction	To E		X Walk 2 Direction	To N
N/A	X Walk 1 Width (in)	N/A	N/A	X Walk 2 Width (in)	N/A
	X Walk 1 Slope (%)	2.7		X Walk 2 Slope (%)	2.9
	X Walk 1 X Slope (%)	3.0		X Walk 2 X Slope (%)	1.9

N/A	Ramp inside XWalk1?	N/A	N/A	Ramp inside XWalk2?	N/A
	Road Slope (%)	0.3	N/A	Clear Space?	N/A
	Road X Slope (%)	5.7	N/A	Clear Space to XWalk (in)	N/A
N/A	Any Obstructions?	N/A	N/A	Storm Grate/Utility Hazard?	N/A
	Obstruction Type			Storm Grate/Utility Type	
		N/A			N/A
		Yes		Surface Condition? (G/P)	Good

Remove & Replace Curb Ramp With Two New Directional Ramps or Equivalent.

R304.5.1, R304.2.2
