# Access Compliance Report

## Public Rights-of-Way

### (Curb Ramps)

| Intersection ID: 44772 | Main Street: KINGS_PARADE_BV | Cross Street: N/A | Location: NW |

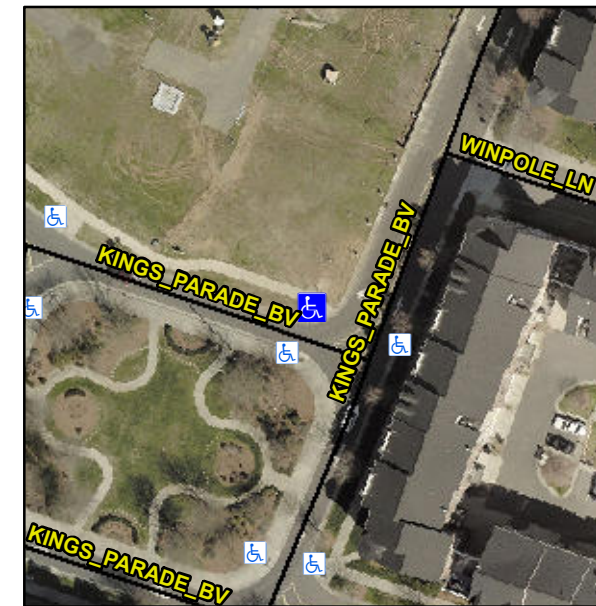
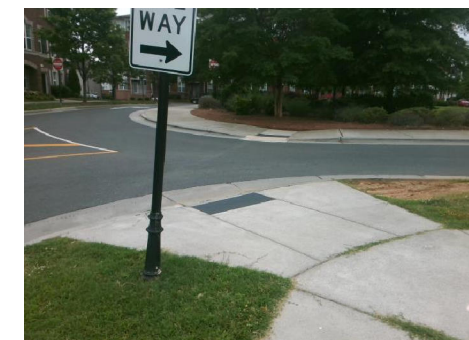
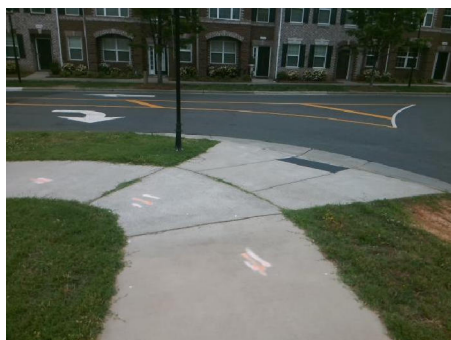
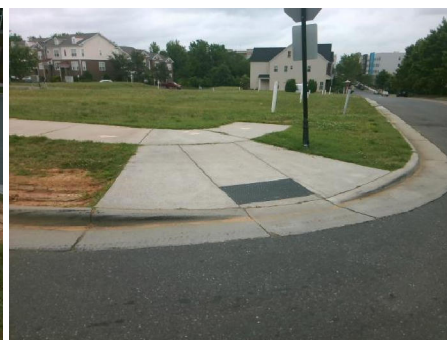
| ADA ID: 26D15D6E578C | Ramp Type: PerpDiag | Initial Pass/Fail: Fail | Overall Compliance: No |

| Severity Score: 22.5 | | | |

**Not Found, R304.5.1, R304.2.2, R304.5.3**

| Compliance | Description | Data | Compliance | Description | Data |
|---|---|---|---|---|---|
| N/A | Ramp Length (in) | 112.0 | No | Ramp Slope (%) | 10.0 |
| No | Ramp Width (in) | 45.0 | No | Ramp XSlope (%) | 4.0 |

**Remove & Replace Curb Ramp With Two New Directional Ramps or Equivalent.**
