Access Compliance Report

Public Rights-of-Way

(Curb Ramps)

Intersection ID: 7979	Main Street: EAGLE_PEAK_DR	Cross Street: DAVID_AV	Location:	S
ADA ID: 26DB55057611	Ramp Type: Perp	Initial Pass/Fail: Fail	Overall Compliance: No	Severity Score: 10
Codes/Mitigation Info/Possible Solution		Field Measurements/Component Compliance

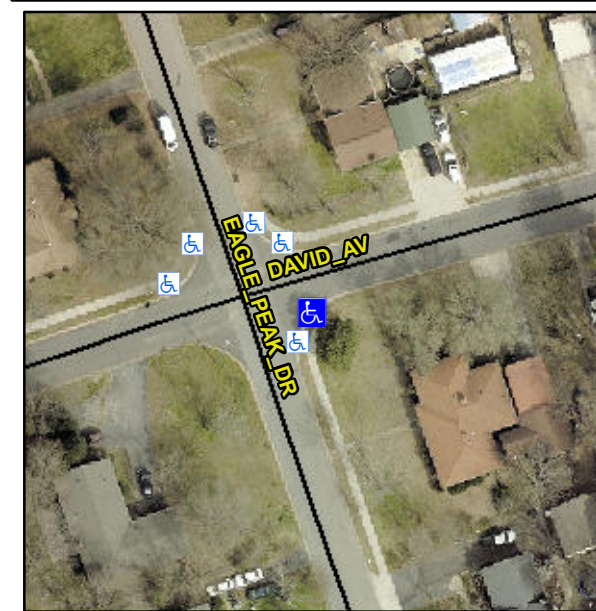
Not Found, R304.5.1, R304.5.3

Compliance	Description	Data	Compliance	Description	Data
N/A	Ramp Length (in)	48.0	Yes	Ramp Slope (%)	6.4
No	Ramp Width (in)	45.5	No	Ramp XSlope (%)	4.9
N/A	Flare Type LT	N/A	N/A	Flare Type RT	N/A
N/A	Flare Slope LT (%)	N/A	N/A	Flare Slope RT (%)	N/A
N/A	Flare Traversable LT?	N/A	N/A	Flare Traversable RT?	N/A
N/A	Landing Length (in)	N/A	N/A	DWS Provided?	N/A
N/A	Landing Width (in)	N/A	N/A	DWS Contrast?	N/A
N/A	Landing Slope (%)	N/A	N/A	DWS Length (in)	N/A
N/A	Landing X Slope (%)	N/A	N/A	DWS Full Width?	N/A
N/A	Landing Curb? (Y/N)	N/A	N/A	DWS Offset (in)	N/A
N/A	Shared Landing?	N/A			
N/A	Gutter Ponding?	N/A	N/A	Gutter Slope (%)	N/A
N/A	Gutter Lip Ht (in)	2.0	N/A	Gutter X Slope (%)	N/A
N/A	Painted X Walk1?	No	N/A	Painted X Walk2?	N/A
	X Walk 1 Direction	To N		X Walk 2 Direction	N/A
N/A	X Walk 1 Width (in)	N/A	N/A	X Walk 2 Width (in)	N/A
	X Walk 1 Slope (%)	4.0		X Walk 2 Slope (%)	N/A
	X Walk 1 X Slope (%)	7.0		X Walk 2 X Slope (%)	N/A

N/A	Ramp inside XWalk1?	N/A	N/A	Ramp inside XWalk2?	N/A
	Road Slope (%)	N/A	N/A	Clear Space?	N/A
	Road X Slope (%)	N/A	N/A	Clear Space to XWalk (in)	N/A
N/A	Any Obstructions?	N/A	N/A	Storm Grate/Utility Hazard?	N/A
	Obstruction Type			Storm Grate/Utility Type	
		N/A			N/A
			Yes	Surface Condition? (G/P)	Good

Possible Solutions:

Remove & Replace Entire Ramp.
