Access Compliance Report

Public Rights-of-Way

(Curb Ramps)

Intersection ID: 10025341	Main Street: E_7TH_ST	Cross Street: N/A	Location: S
ADA ID: 26E183CC8AAC	Ramp Type: Directional1	Initial Pass/Fail: Fail	Overall Compliance: No
		Severity Score: 12.5

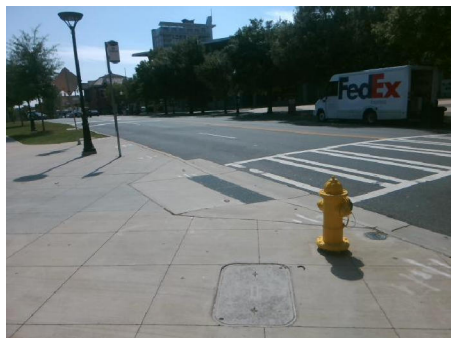
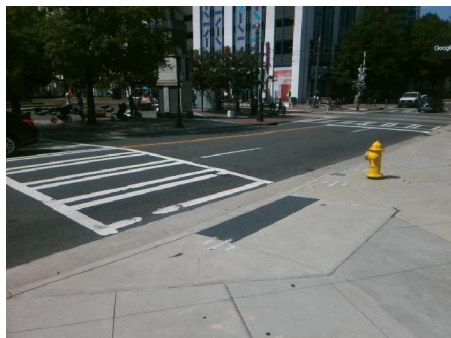
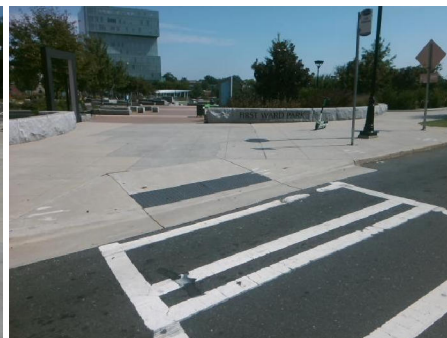
Compliance	Description	Data	Compliance	Description	Data
N/A	Ramp Length (in)	72.0	N/A	Grade Break?	N/A
Yes	Ramp Width (in)	96.0	N/A	Grade Break Slope (%)	0.0
No	Ramp Slope (%)	9.3	N/A	Grade Break XSlope (%)	0.0
Yes	Ramp XSlope (%)	1.7			
N/A	Flare Type LT	N/A	N/A	Flare Type RT	N/A
N/A	Flare Slope LT (%)	N/A	N/A	Flare Slope RT (%)	0.0
N/A	Flare Traversable LT?	N/A	N/A	Flare Traversable RT?	N/A
N/A	Landing Length (in)	0.0	N/A	DWS Provided?	N/A
N/A	Landing Width (in)	0.0	N/A	DWS Contrast?	N/A
N/A	Landing Slope (%)	0.0	N/A	DWS Length (in)	N/A
N/A	Landing X Slope (%)	0.0	N/A	DWS Full Width?	N/A
N/A	Landing Curb? (Y/N)	N/A	N/A	DWS Offset LT (in)	N/A
N/A	Shared Landing?	N/A	N/A	DWS Offset RT (in)	N/A
N/A	Gutter Ponding?	0.0	N/A	Gutter Slope (%)	N/A
N/A	Gutter Lip Ht (in)	0.0	N/A	Gutter X Slope (%)	N/A
N/A	Painted X Walk1?	Yes		Road Slope (%)	3.8
	X Walk 1 Direction	To NE		Road X Slope (%)	4.2
	X Walk 1 Width (in)	142.0		Clear Space?	N/A

X Walk 1 Slope (%)	3.8	N/A	Clear Space to XWalk (in)	N/A
	X Walk 1 X Slope (%)	4.2	N/A	Storm Grate/Utility Hazard?	N/A
N/A	Ramp inside XWalk1?	Yes		Storm Grate/Utility Type	
N/A	Any Obstructions?	N/A			N/A
	Obstruction Type		Yes	Surface Condition? (G/P)	Good
			N/A	Curb Slope (%)	2.9

Remove & Replace Entire Ramp.
