Access Compliance Report

Public Rights-of-Way

(Curb Ramps)

Intersection ID: 29377	Main Street: BUCKVALLEY_DR	Cross Street: EULER_WY	Location: SW
ADA ID: 26F98D2C6872	Ramp Type: PerpDiag	Initial Pass/Fail: Fail	Overall Compliance: No
Severity Score: 46.25			
Codes/Mitigation Info/Possible Solution		Field Measurements/Component Compliance

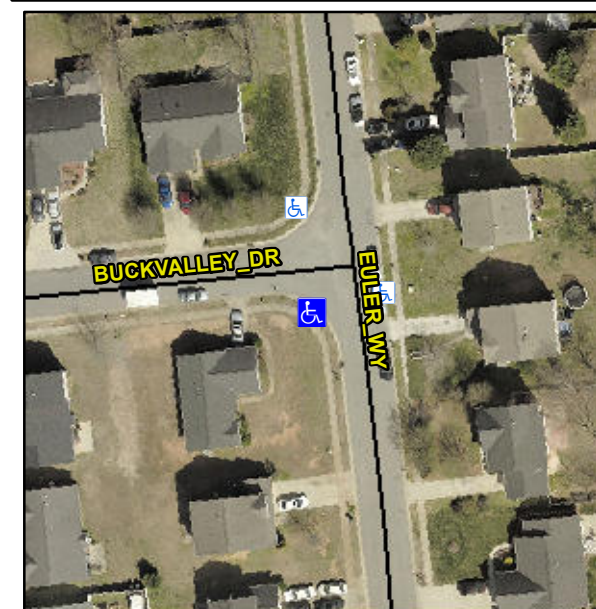
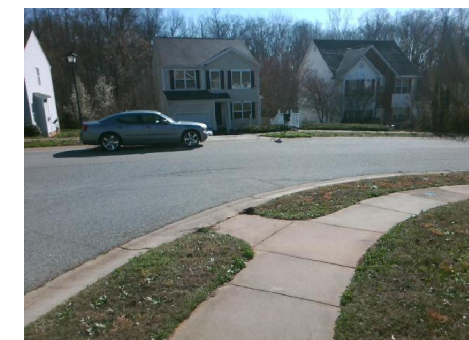
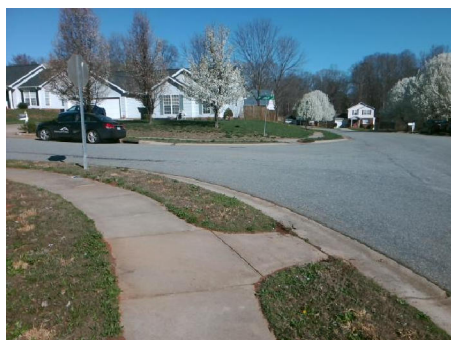
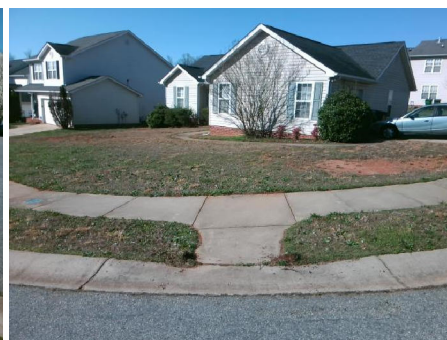
Not Found, R304.5.1, R304.2.2, R304.5.3

Compliance	Description	Data	Compliance	Description	Data
N/A	Ramp Length (in)	96.0	No	Ramp Slope (%)	10.1
No	Ramp Width (in)	46.5	No	Ramp XSlope (%)	7.1
N/A	Flare Type LT	N/A	N/A	Flare Type RT	N/A
N/A	Flare Slope LT (%)	N/A	N/A	Flare Slope RT (%)	N/A
N/A	Flare Traversable LT?	N/A	N/A	Flare Traversable RT?	N/A
N/A	Landing Length (in)	N/A	N/A	DWS Provided?	N/A
N/A	Landing Width (in)	N/A	N/A	DWS Contrast?	N/A
N/A	Landing Slope (%)	N/A	N/A	DWS Length (in)	N/A
N/A	Landing X Slope (%)	N/A	N/A	DWS Full Width?	N/A
N/A	Landing Curb? (Y/N)	N/A	N/A	DWS Offset (in)	N/A
N/A	Shared Landing?	N/A			
N/A	Gutter Ponding?	N/A	N/A	Gutter Slope (%)	N/A
N/A	Gutter Lip Ht (in)	N/A	N/A	Gutter X Slope (%)	N/A
N/A	Painted X Walk1?	No	N/A	Painted X Walk2?	No
	X Walk 1 Direction	To E		X Walk 2 Direction	To N
N/A	X Walk 1 Width (in)	N/A	N/A	X Walk 2 Width (in)	N/A
	X Walk 1 Slope (%)	3.2		X Walk 2 Slope (%)	3.3
	X Walk 1 X Slope (%)	3.8		X Walk 2 X Slope (%)	4.5

N/A	Ramp inside XWalk1?	N/A	N/A	Ramp inside XWalk2?	N/A
	Road Slope (%)	5.2	N/A	Clear Space?	N/A
	Road X Slope (%)	0.9	N/A	Clear Space to XWalk (in)	N/A
N/A	Any Obstructions?	N/A	N/A	Storm Grate/Utility Hazard?	N/A
	Obstruction Type			Storm Grate/Utility Type	
		N/A			N/A
			Yes	Surface Condition? (G/P)	Good

Remove & Replace Curb Ramp With Two New Directional Ramps or Equivalent.
