# Access Compliance Report

## Public Rights-of-Way

| Intersection ID: 30034 | Main Street: DAY_LILLY_LN | Cross Street: SUMMER_COACH_DR | Location: SE |
| ADA ID: 2713BC9EA851 | Ramp Type: PerpDiag | Initial Pass/Fail: Fail | Overall Compliance: No |

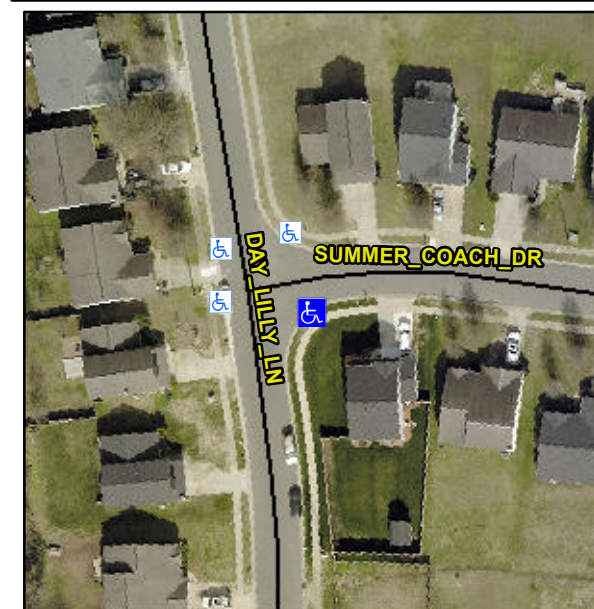
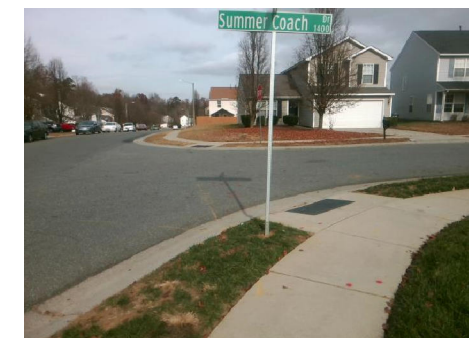
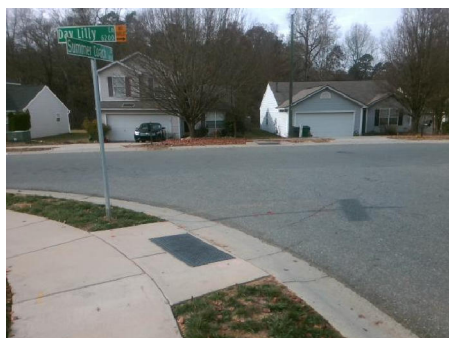
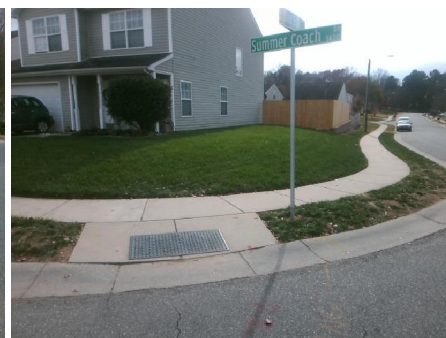
**Not Found, R304.2.2, R304.5.3**

| Compliance | Description | Data | Compliance | Description | Data |
|---|---|---|---|---|---|
| N/A | Ramp Length (in) | 47.5 | No | Ramp Slope (%) | 10.4 |
| Yes | Ramp Width (in) | 48.0 | No | Ramp XSlope (%) | 2.6 |

**Remove & Replace Curb Ramp With Two New Directional Ramps or Equivalent.**
