# Access Compliance Report

## Public Rights-of-Way

### (Curb Ramps)

| Intersection ID: 17085 | Main Street: CROYDON_RD | Cross Street: SELWYN_AV | Location: SW |

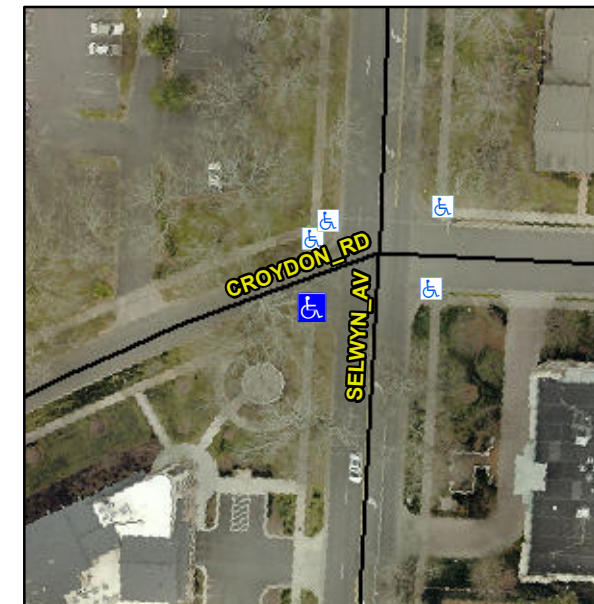
| ADA ID: 2718517AFBEC | Ramp Type: PerpDiag | Initial Pass/Fail: Fail | Overall Compliance: No |

**R304.2.2**

| Compliance | Description | Data | Compliance | Description | Data |
|---|---|---|---|---|---|
| N/A | Ramp Length (in) | 72.0 | No | Ramp Slope (%) | 11.5 |

**Remove & Replace Curb Ramp With Two New Directional Ramps or Equivalent.**
