Access Compliance Report

Public Rights-of-Way

(Curb Ramps)

Intersection ID: 11273	Main Street: E_21ST_ST	Cross Street: N_DAVIDSON_ST	Location: NW
ADA ID: 271E56A59AFA	Ramp Type: Perp	Initial Pass/Fail: Fail	Overall Compliance: No
Severity Score: 33.75			
Codes/Mitigation Info/Possible Solution		Field Measurements/Component Compliance

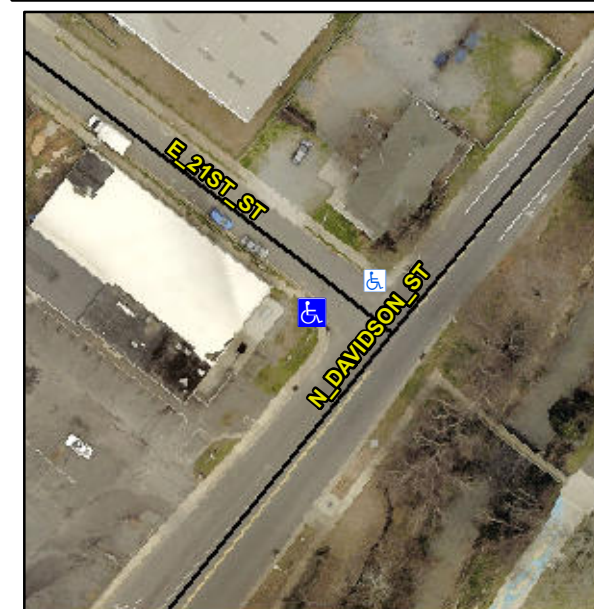
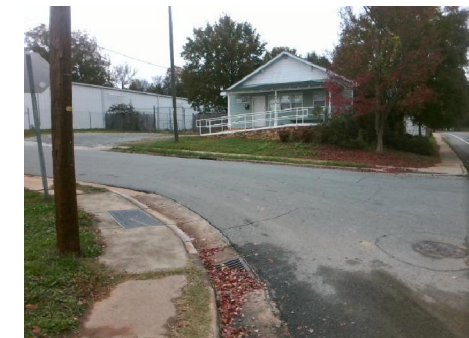
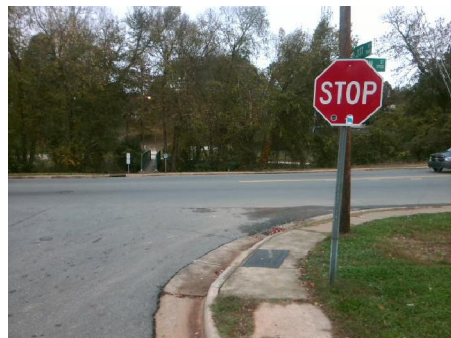
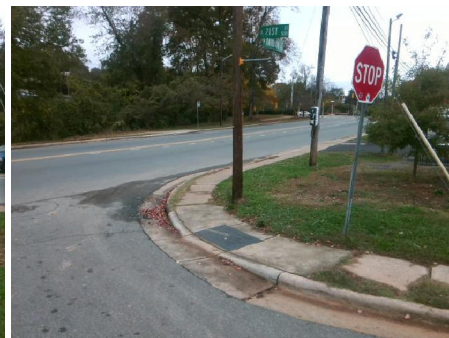
Not Found, R304.5.1, R304.5.3

Compliance	Description	Data	Compliance	Description	Data
N/A	Ramp Length (in)	47.0	Yes	Ramp Slope (%)	6.6
No	Ramp Width (in)	41.5	No	Ramp XSlope (%)	8.3
N/A	Flare Type LT	N/A	N/A	Flare Type RT	N/A
N/A	Flare Slope LT (%)	N/A	N/A	Flare Slope RT (%)	N/A
N/A	Flare Traversable LT?	N/A	N/A	Flare Traversable RT?	N/A
N/A	Landing Length (in)	N/A	N/A	DWS Provided?	N/A
N/A	Landing Width (in)	N/A	N/A	DWS Contrast?	N/A
N/A	Landing Slope (%)	N/A	N/A	DWS Length (in)	N/A
N/A	Landing X Slope (%)	N/A	N/A	DWS Full Width?	N/A
N/A	Landing Curb? (Y/N)	N/A	N/A	DWS Offset (in)	N/A
N/A	Shared Landing?	N/A			
N/A	Gutter Ponding?	N/A	N/A	Gutter Slope (%)	N/A
N/A	Gutter Lip Ht (in)	N/A	N/A	Gutter X Slope (%)	N/A
N/A	Painted X Walk1?	No	N/A	Painted X Walk2?	N/A
	X Walk 1 Direction	To NE		X Walk 2 Direction	N/A
N/A	X Walk 1 Width (in)	N/A	N/A	X Walk 2 Width (in)	N/A
	X Walk 1 Slope (%)	4.2		X Walk 2 Slope (%)	N/A
	X Walk 1 X Slope (%)	7.1		X Walk 2 X Slope (%)	N/A

N/A	Ramp inside XWalk1?	N/A	N/A	Ramp inside XWalk2?	N/A
	Road Slope (%)	N/A	N/A	Clear Space?	N/A
	Road X Slope (%)	N/A	N/A	Clear Space to XWalk (in)	N/A
N/A	Any Obstructions?	N/A	N/A	Storm Grate/Utility Hazard?	N/A
	Obstruction Type			Storm Grate/Utility Type	
		N/A			N/A
			Yes	Surface Condition? (G/P)	Good

Remove & Replace Entire Ramp.

Total Cost: \$ 1850.00
