# Access Compliance Report

## Public Rights-of-Way

| Intersection ID: 14871 | Main Street: DRIFTWOOD_DR | Cross Street: WINTERFIELD_PL | Location: | E |
| ADA ID: 272994F7D08F | Ramp Type: BlendTrans1 | Initial Pass/Fail: Fail | Overall Compliance: No | Severity Score: 10 |

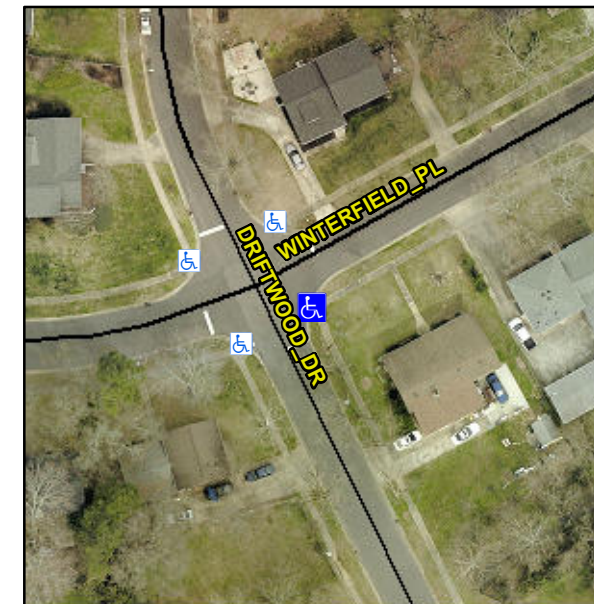
**Not Found, R304.5.1, R304.5.3**

| Compliance | Description | Data | Compliance | Description | Data |
|---|---|---|---|---|---|
| No | Ramp Width (in) | 47.5 | No | BlendTrans XSlope (%) | 4.9 |
| | | | No | Curb Slope (%) | 5.3 |

**Remove & Replace Curb Ramp With Two New Directional Ramps or Equivalent.**

Total Cost: \$ 3200.00
