# Access Compliance Report

## Public Rights-of-Way

### (Curb Ramps)

| Intersection ID: 48452 | Main Street: RED_RUST_LN | Cross Street: BURNT_LEATHER_LN | Location: SW |

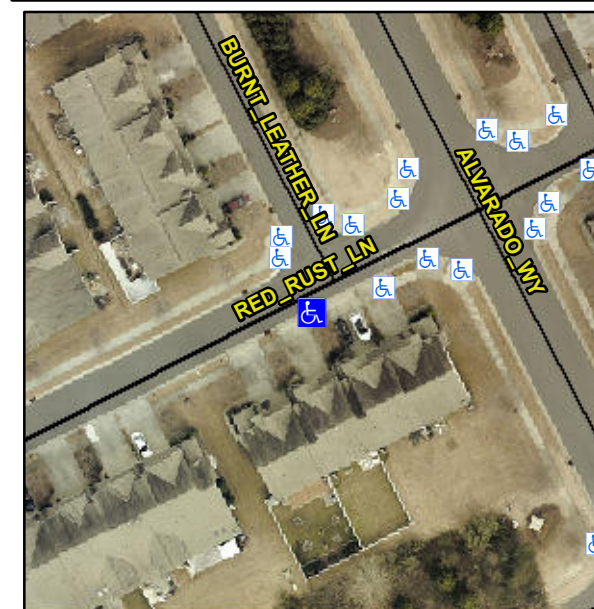
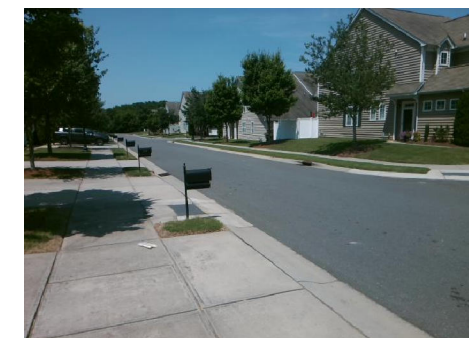
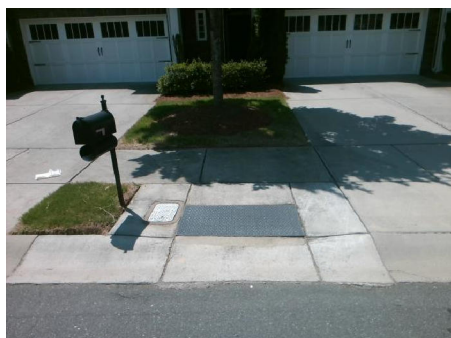
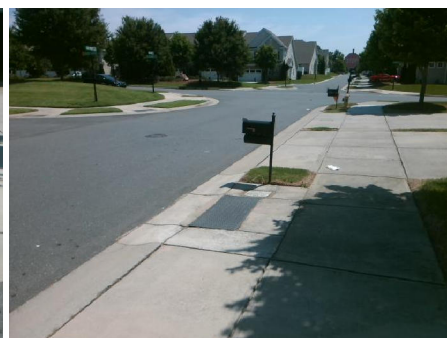
| ADA ID: 272DD64BA454 | Ramp Type: Perp | Initial Pass/Fail: Fail | Overall Compliance: No |
| Severity Score: 10 | | | |

**Not Found, R304.5.1, R304.5.3**

| Compliance | Description | Data | Compliance | Description | Data |
|---|---|---|---|---|---|
| N/A | Ramp Length (in) | 47.0 | Yes | Ramp Slope (%) | 5.1 |
| No | Ramp Width (in) | 47.0 | No | Ramp XSlope (%) | 2.4 |

**Remove & Replace Entire Ramp.**

Total Cost: \$ 1850.00
